Valley of the Kings & West Valley  
Plan 1:1,500 Contour Interval 10m

Sheet 1/72 - KV & WV (1/1)

Theban Mapping Project  
**KV 1 - Ramesses VII Dyn. XX**  
 Plan, sections 1:125, Axonometric  
 Sheet 7/72 - KV 1 (1/1)

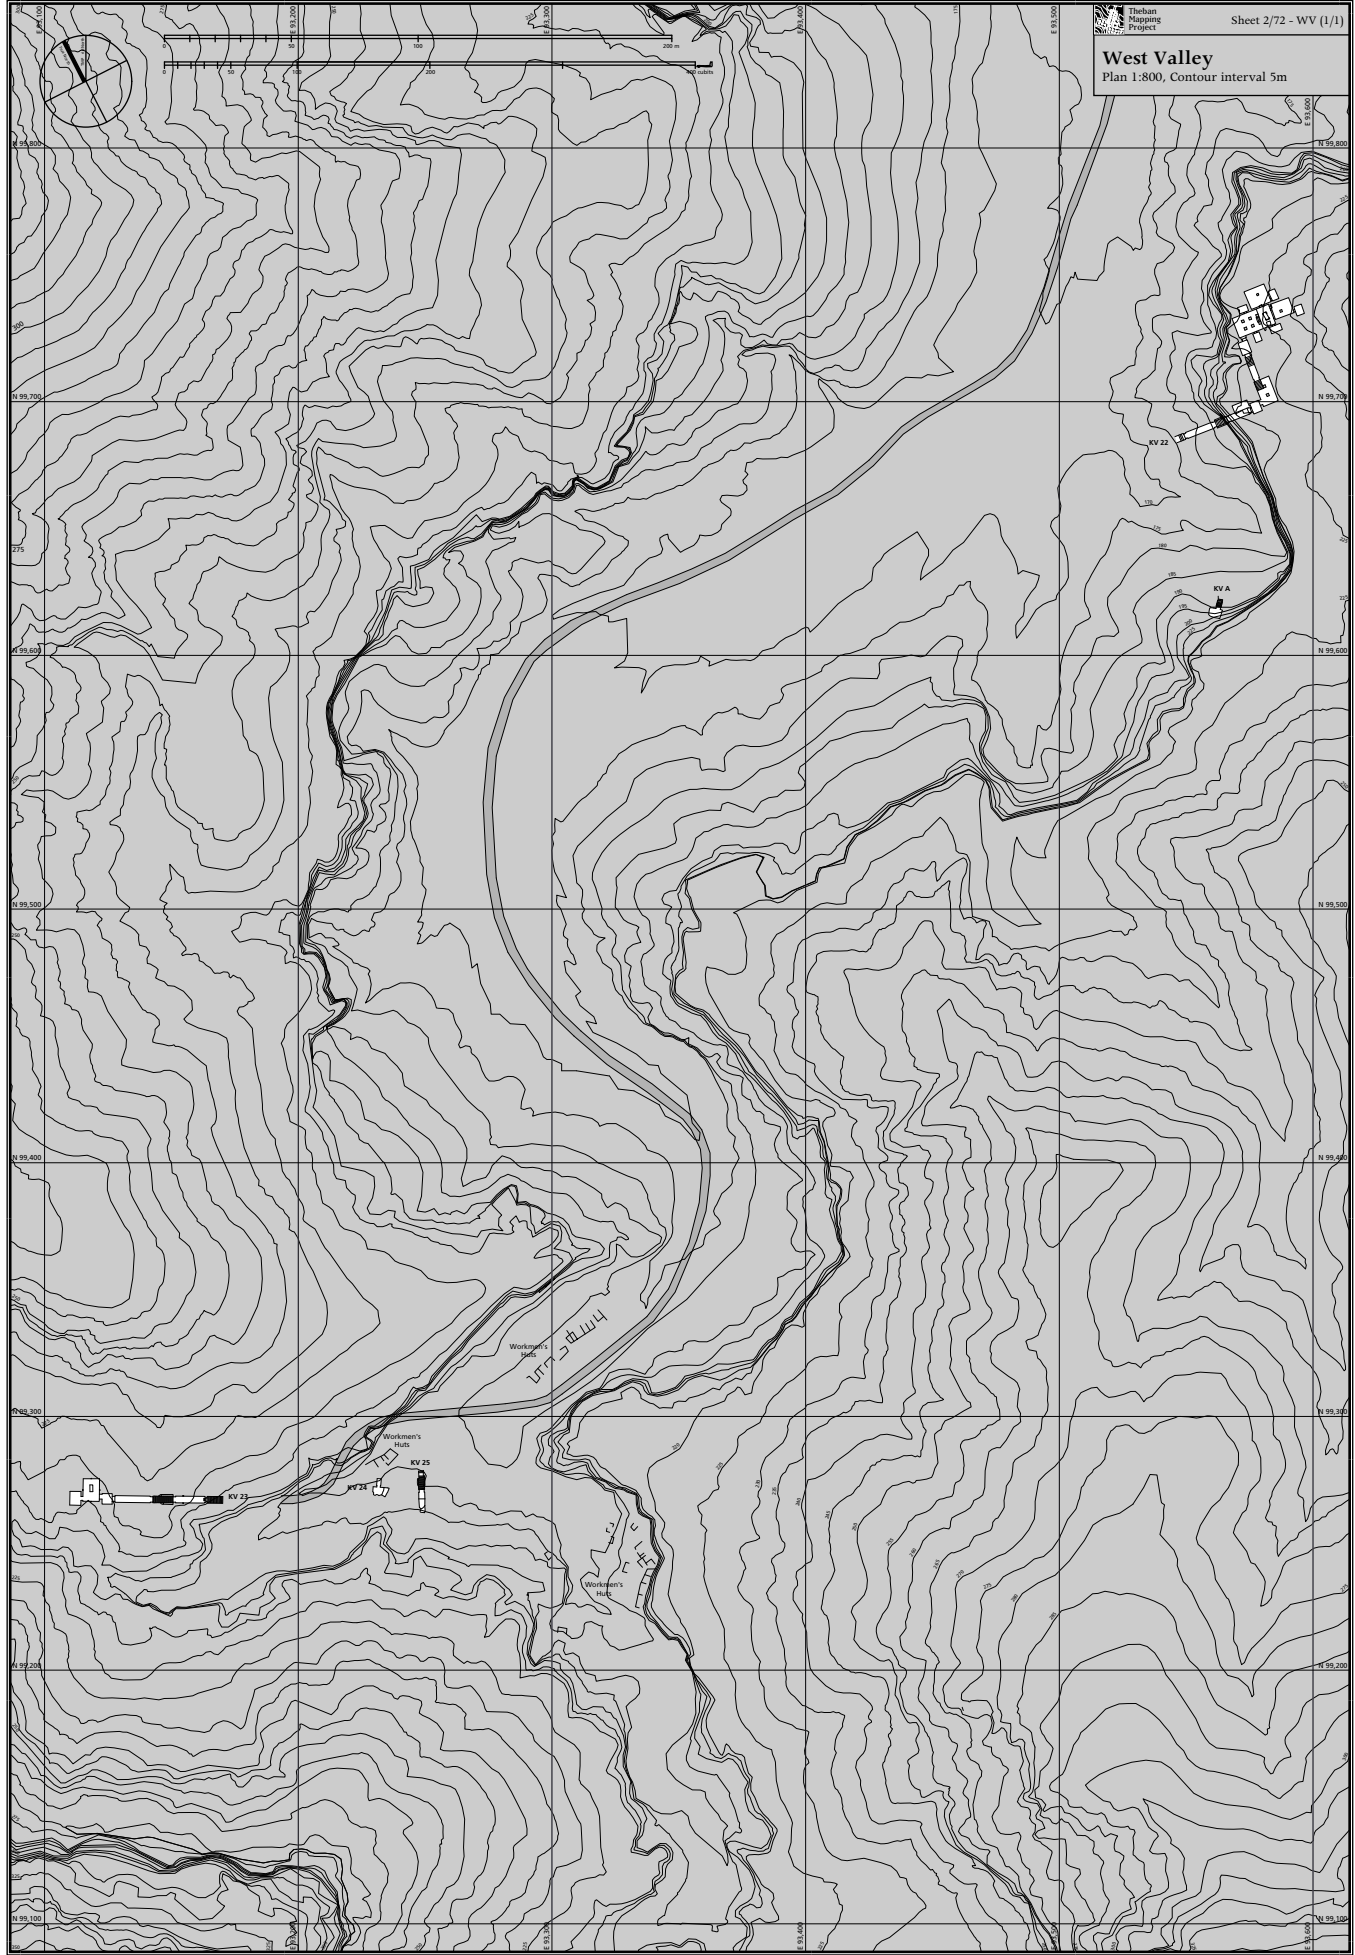
Valley of the Kings  
Plan 1:800, Contour interval 5m

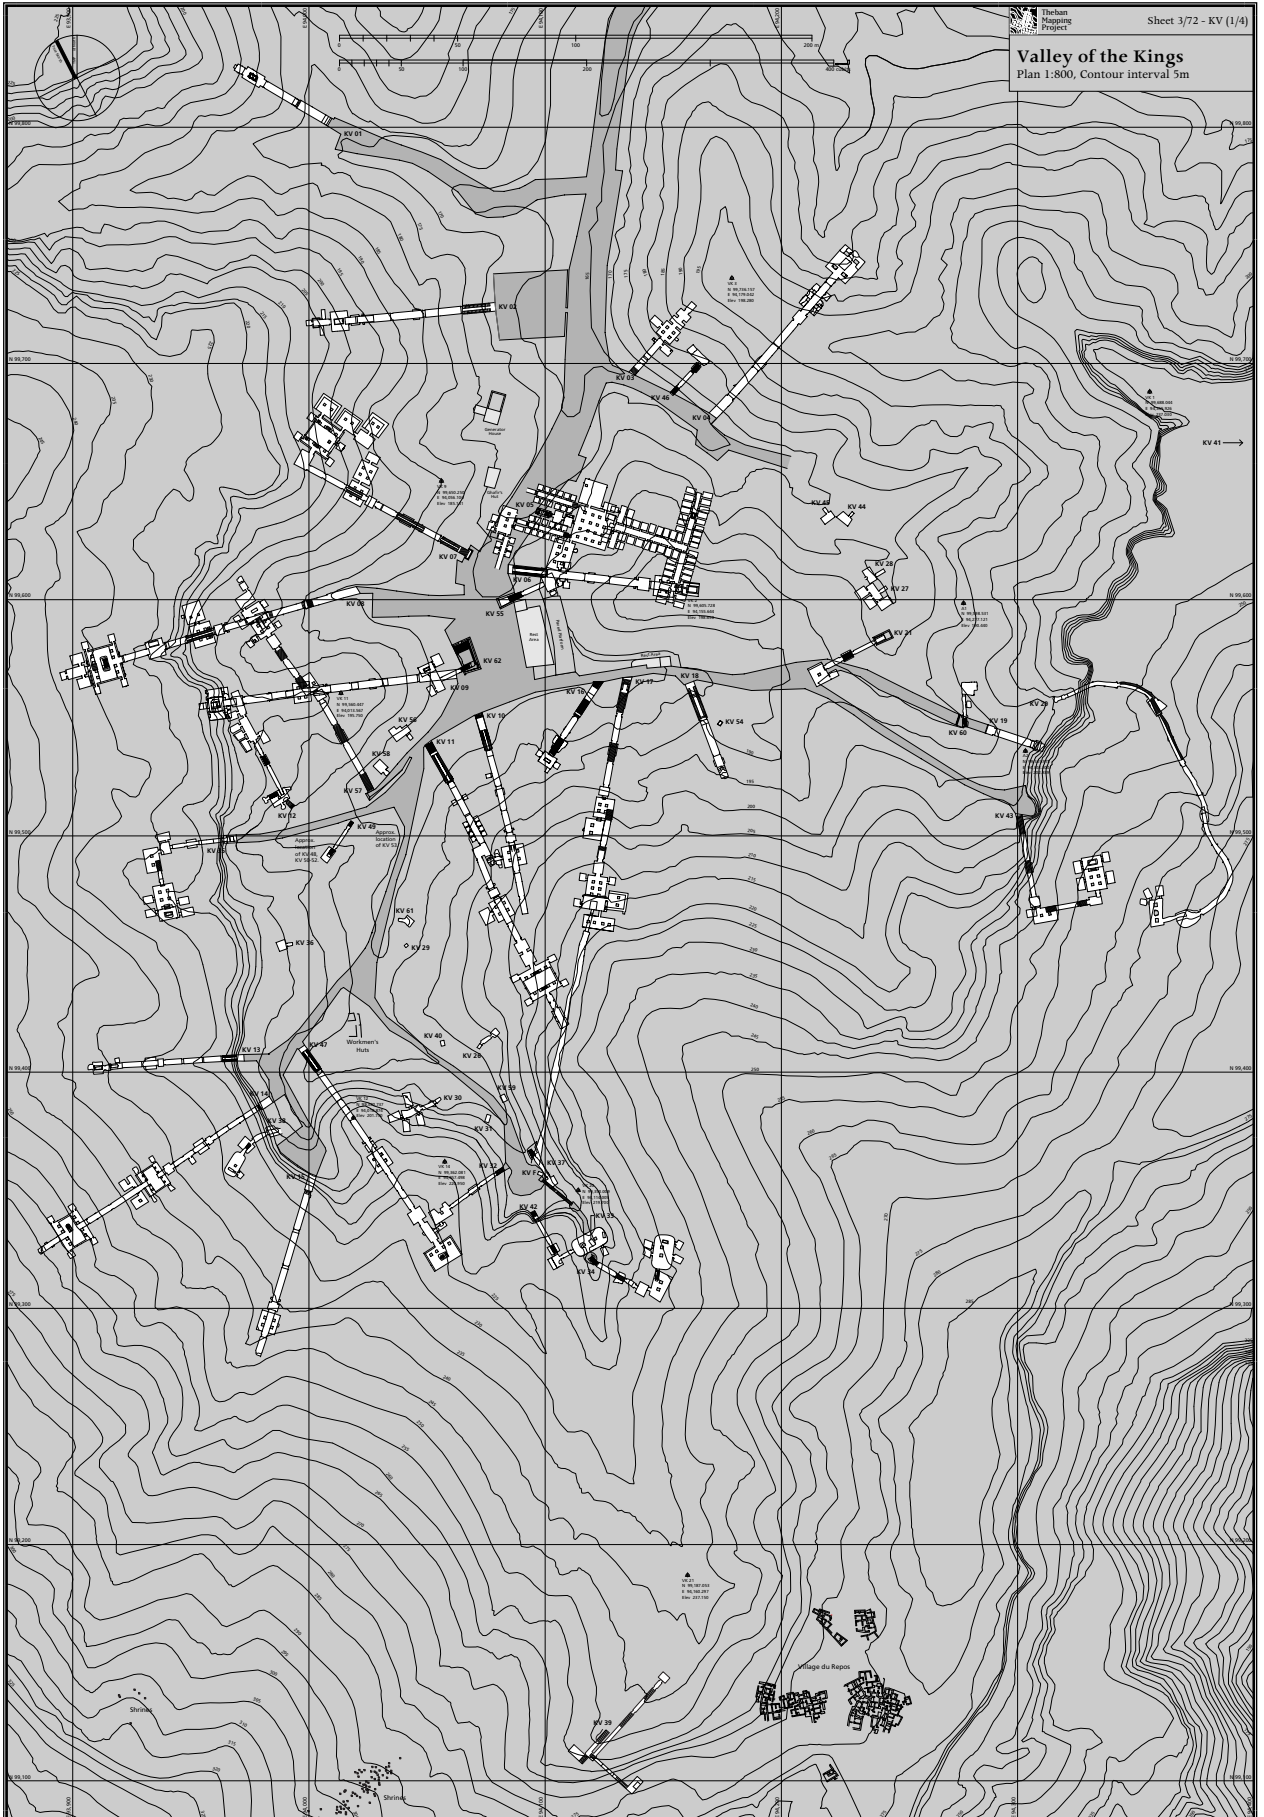
NOTES	
1	Modern steps at tomb entrance.
2	Canopic jar emplacement.
3	Outline of sarcophagus above pit.
4	Beam slot in wall, with broken edges. Recently filled in.
5	Beam hole in wall covered with ancient painted plaster. Dimension and location approximate.

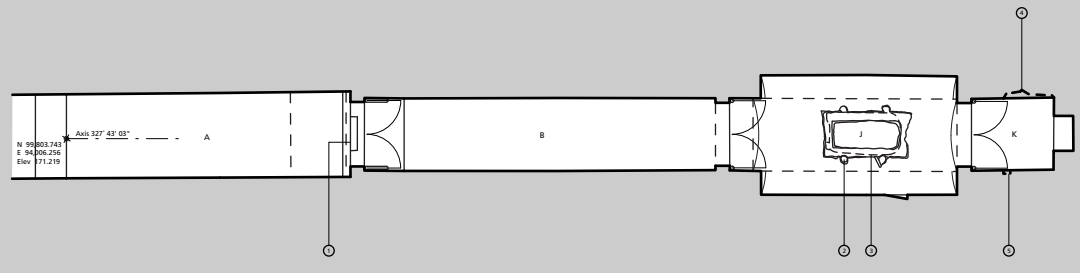
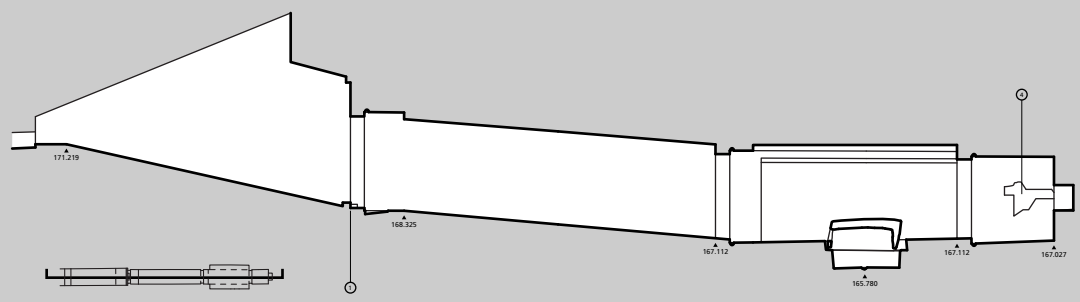
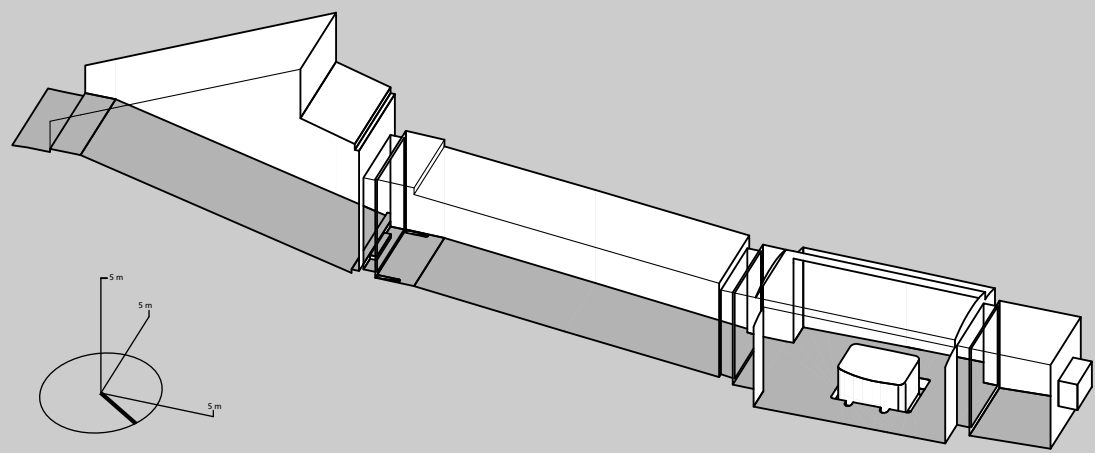
NOTES  
1. Modern gate in tomb entrance.

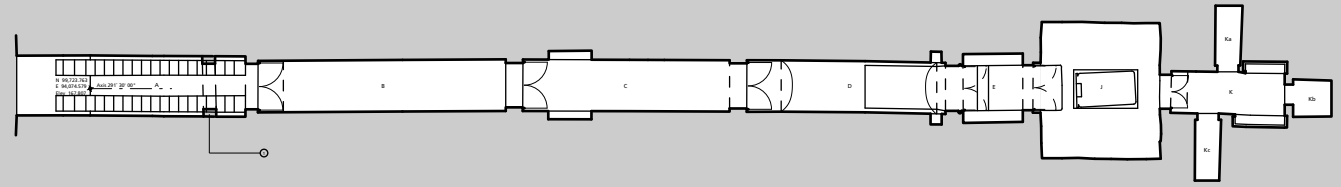
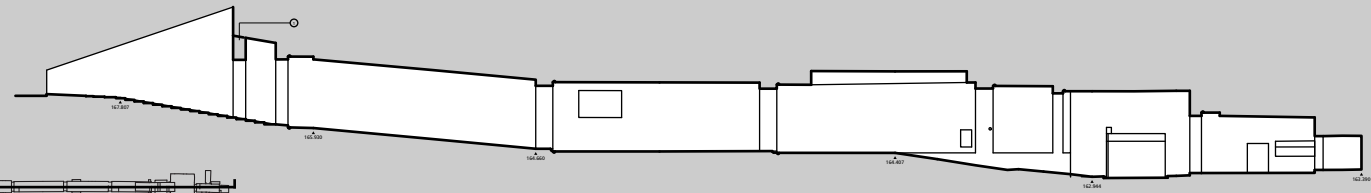
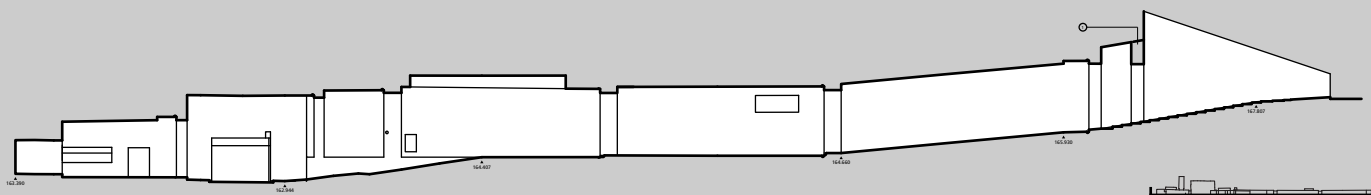
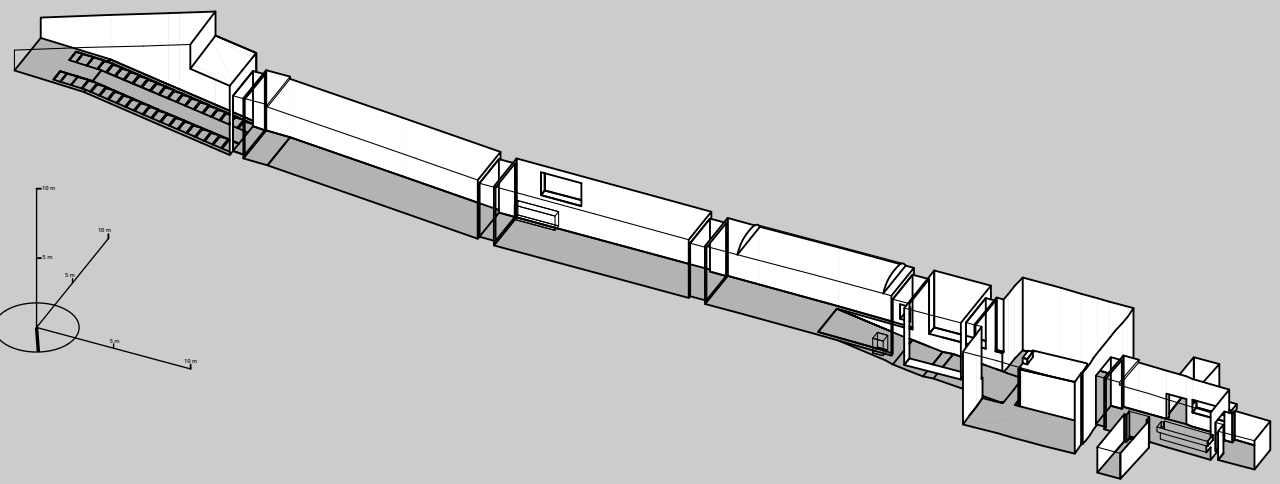
- NOTES
- 1 Modern steps in tomb entryway.
  - 2 Unfinished cutting of chamber.

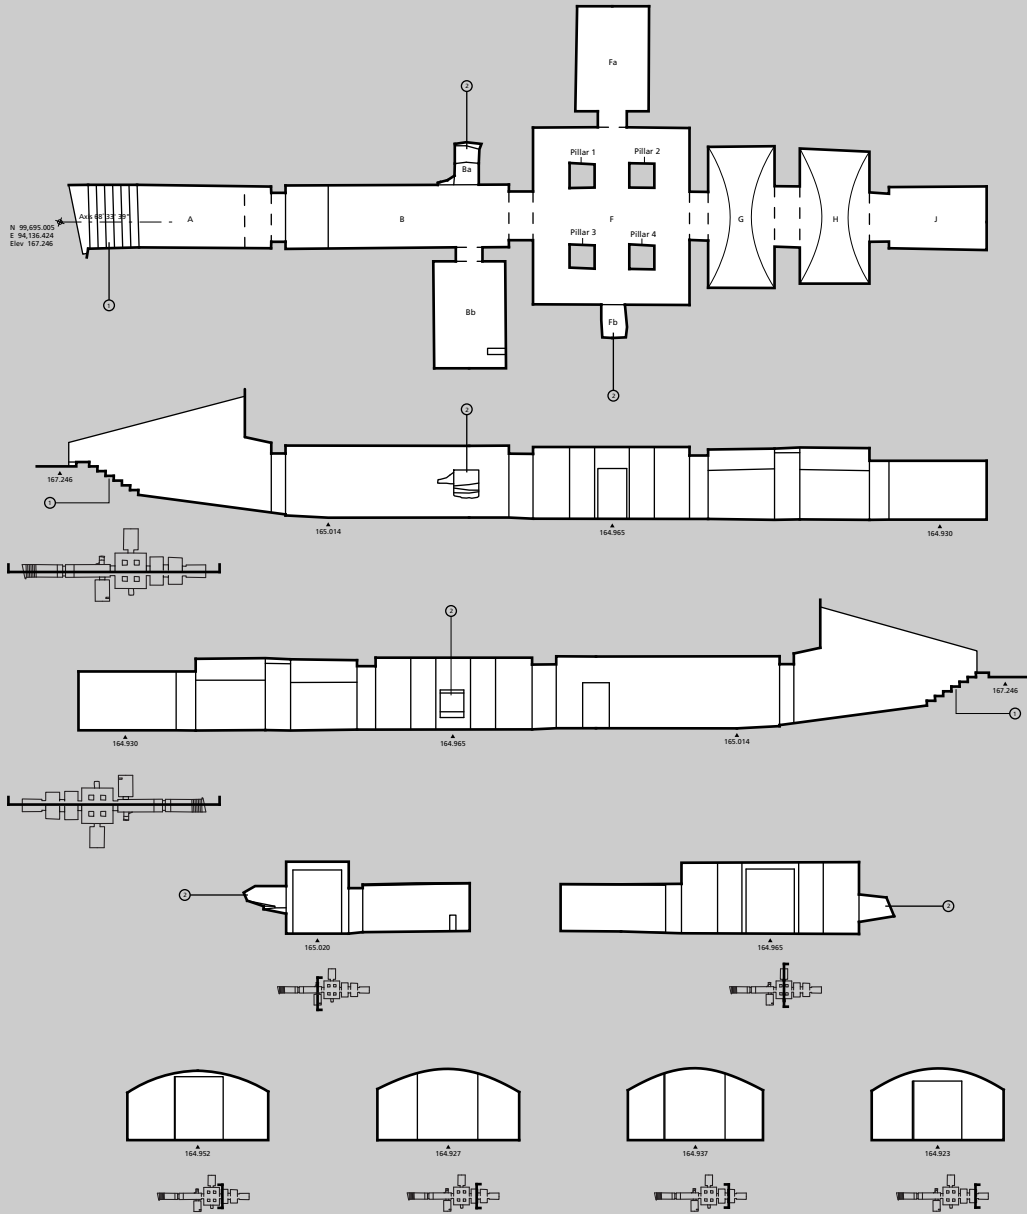
**KV 3 - son of Ramesses III Dyn. XX**  
 Plan, sections 1:125, Axonometric

NOTES  
 1 Socket for wooden beam that supported the fractured section of the overhang. The beam and the section have fallen away.

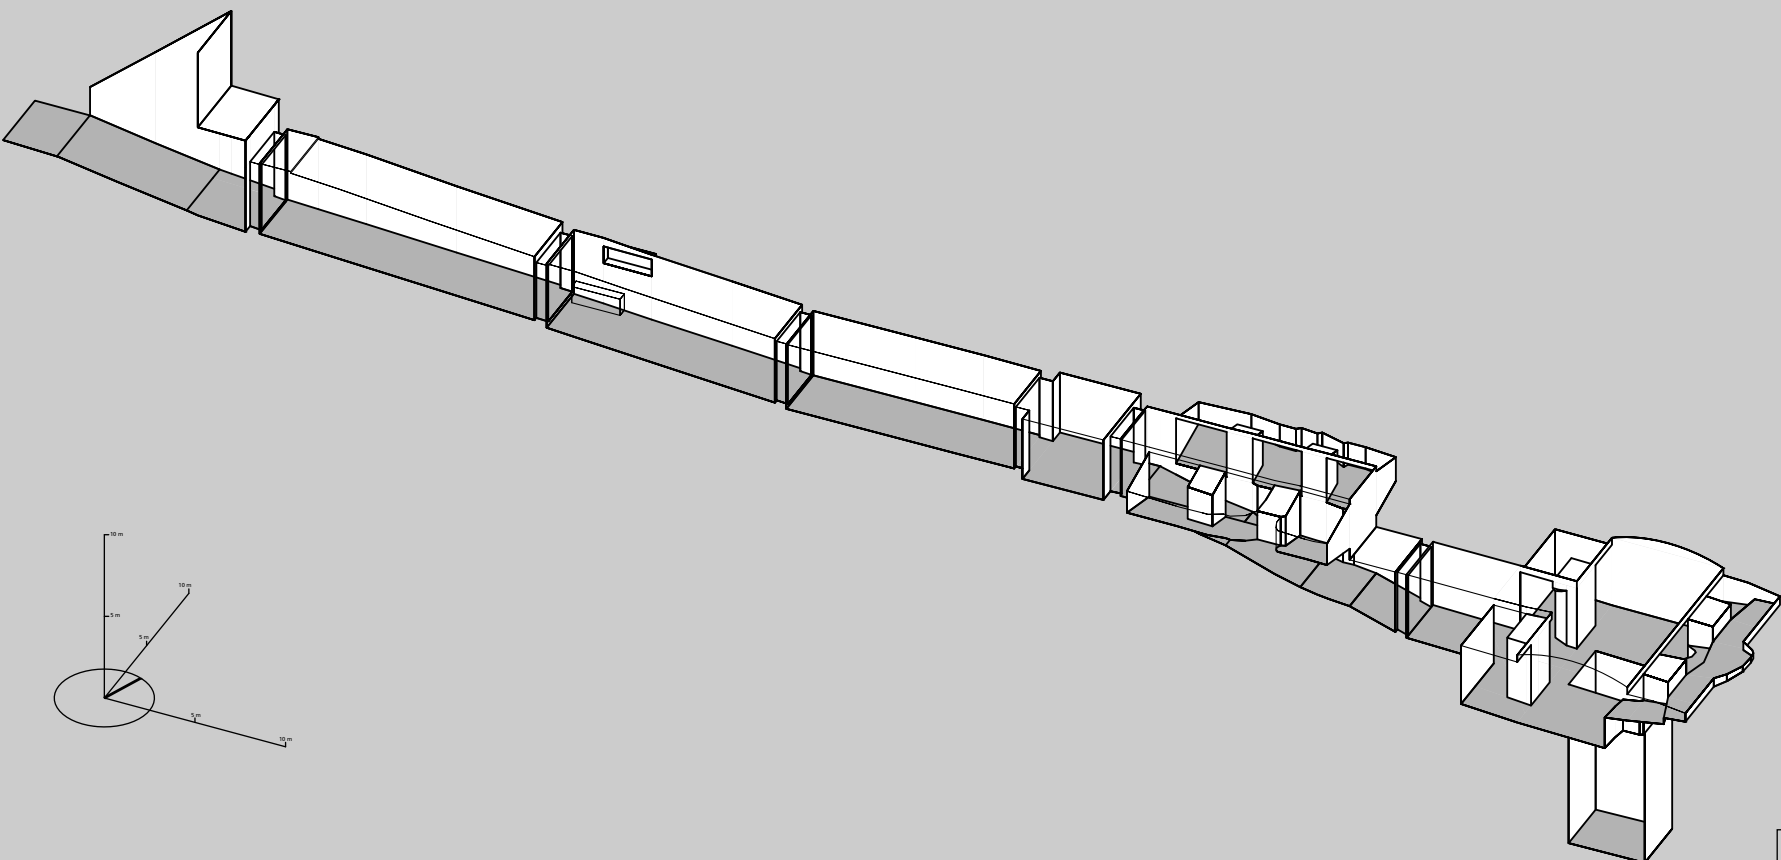
1	Modern courtyard steps.
2	Pillars rows 2.
3	Remaining lower slab over pit.
4	Pillar construction of stone blocks.
5	Area unexcavated, ramp or stairs suspected.

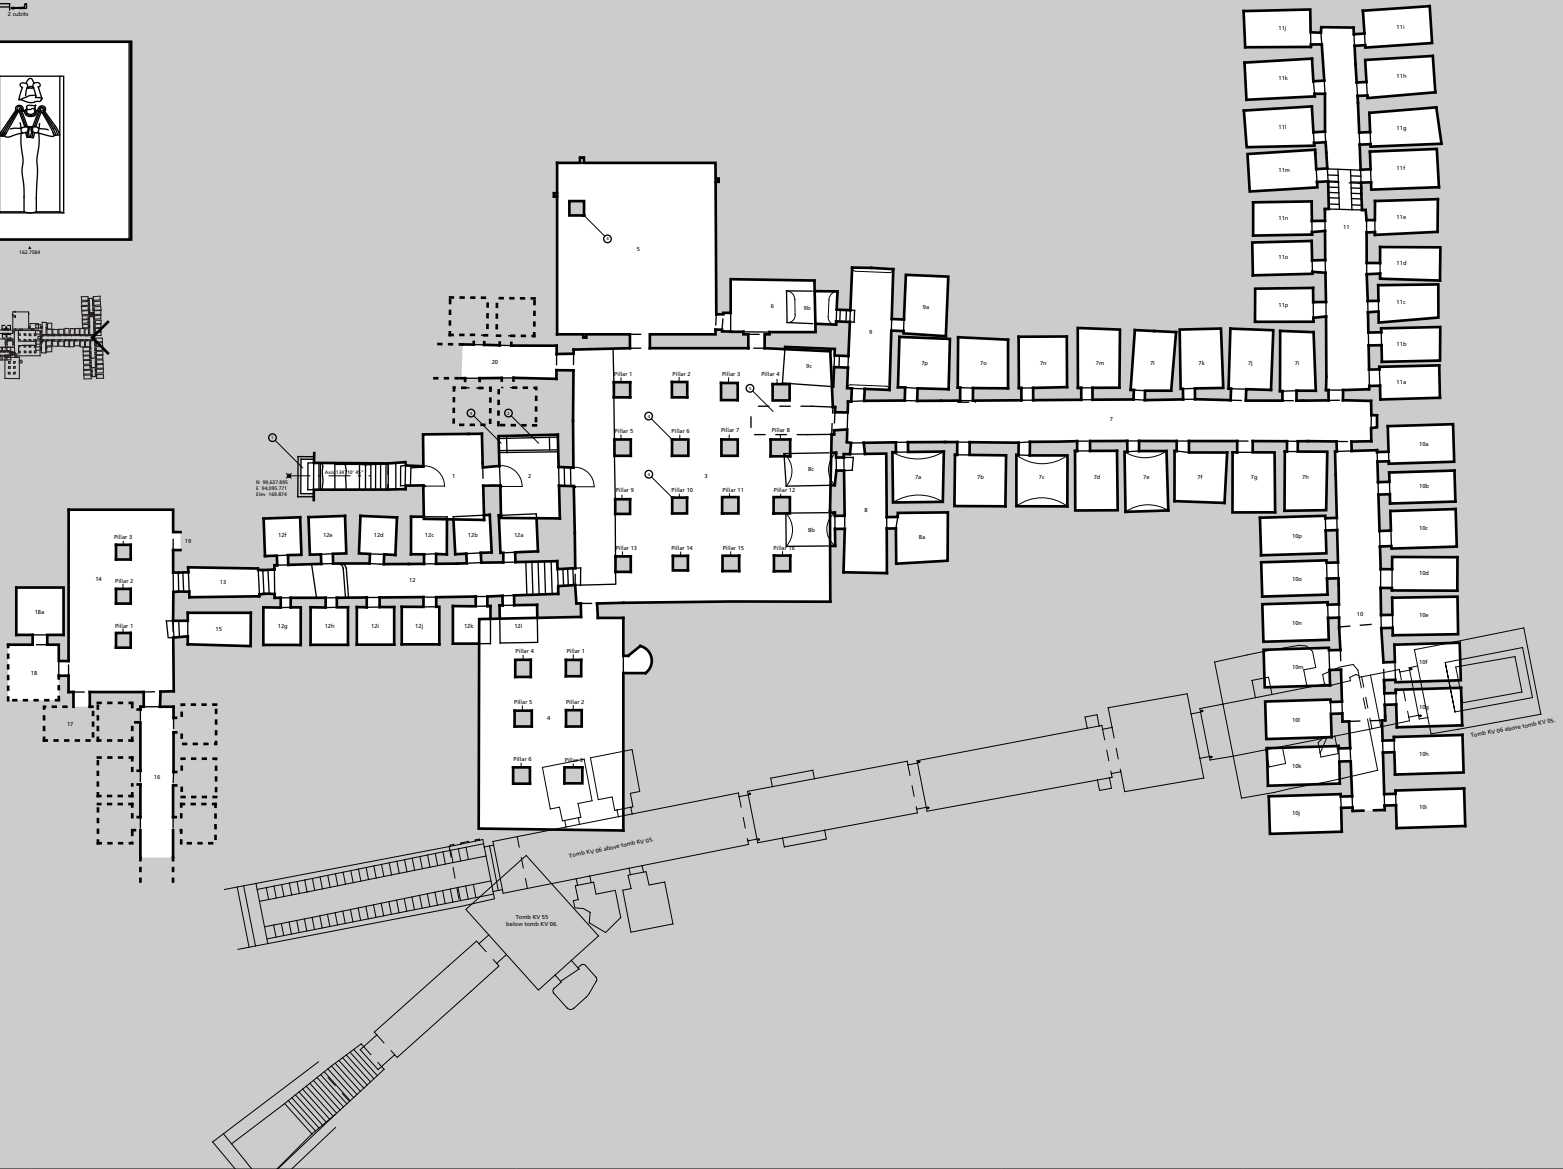
NOTES	
1	Modern curb and steps.
2	PI in chamber 2.
3	Remaining lower slab over pit.
4	Original floor level.
5	Area unexcavated, ramp or stairs suggested.

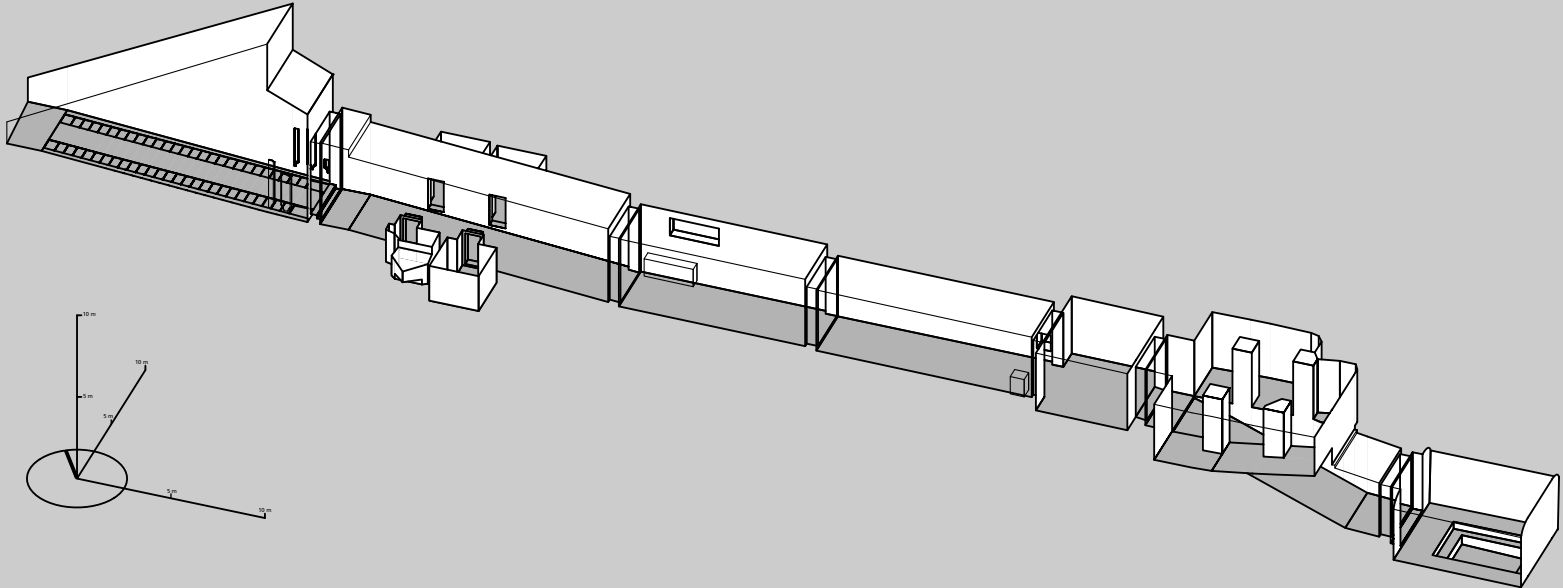
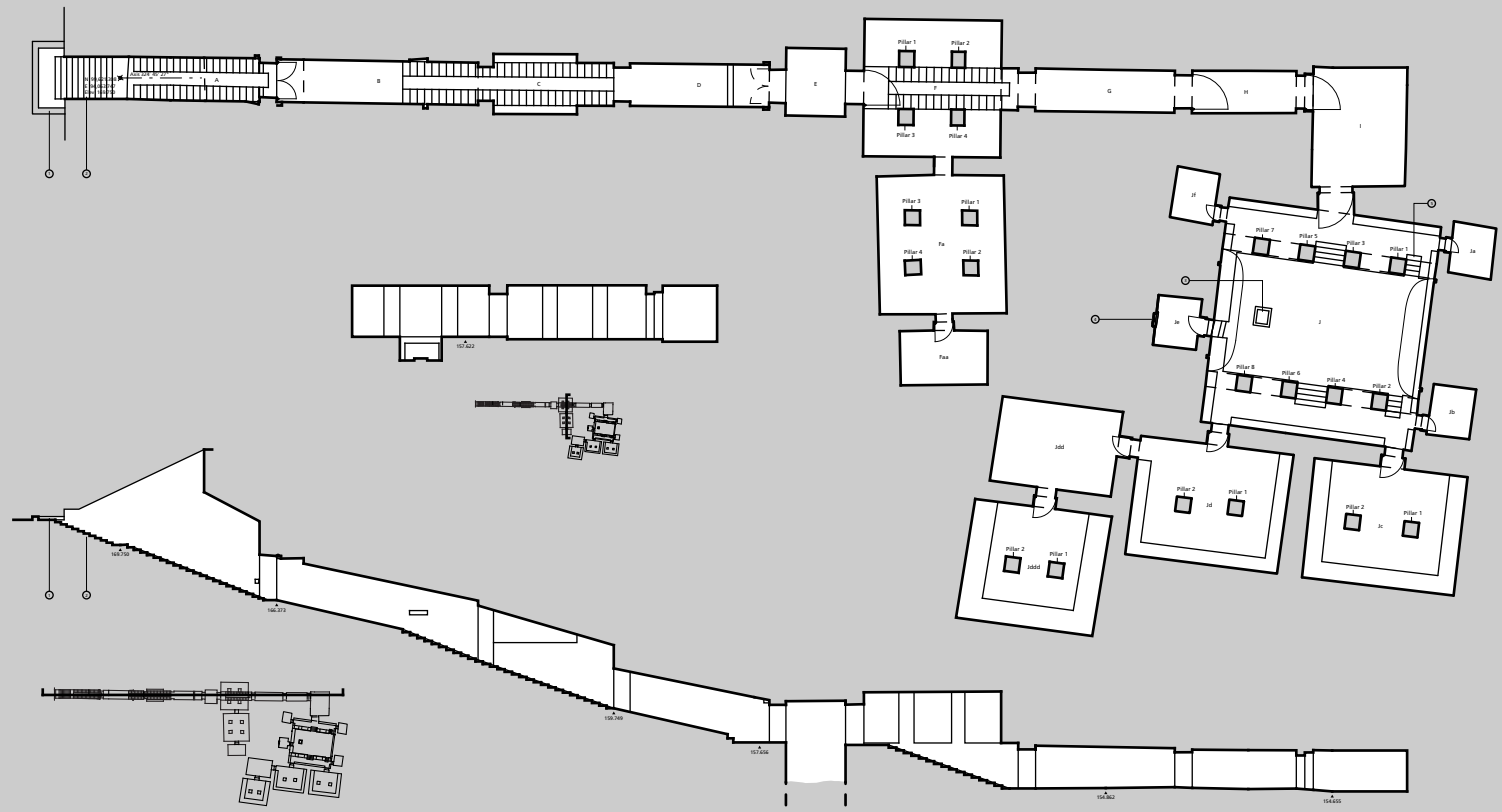
Notes
1 Modern cuts.
2 Modern steps.
3 Fit in floor dimensions and location approximate.
4 Areas with broken figure.
5 Steps assumed in this position, currently unexcavated.

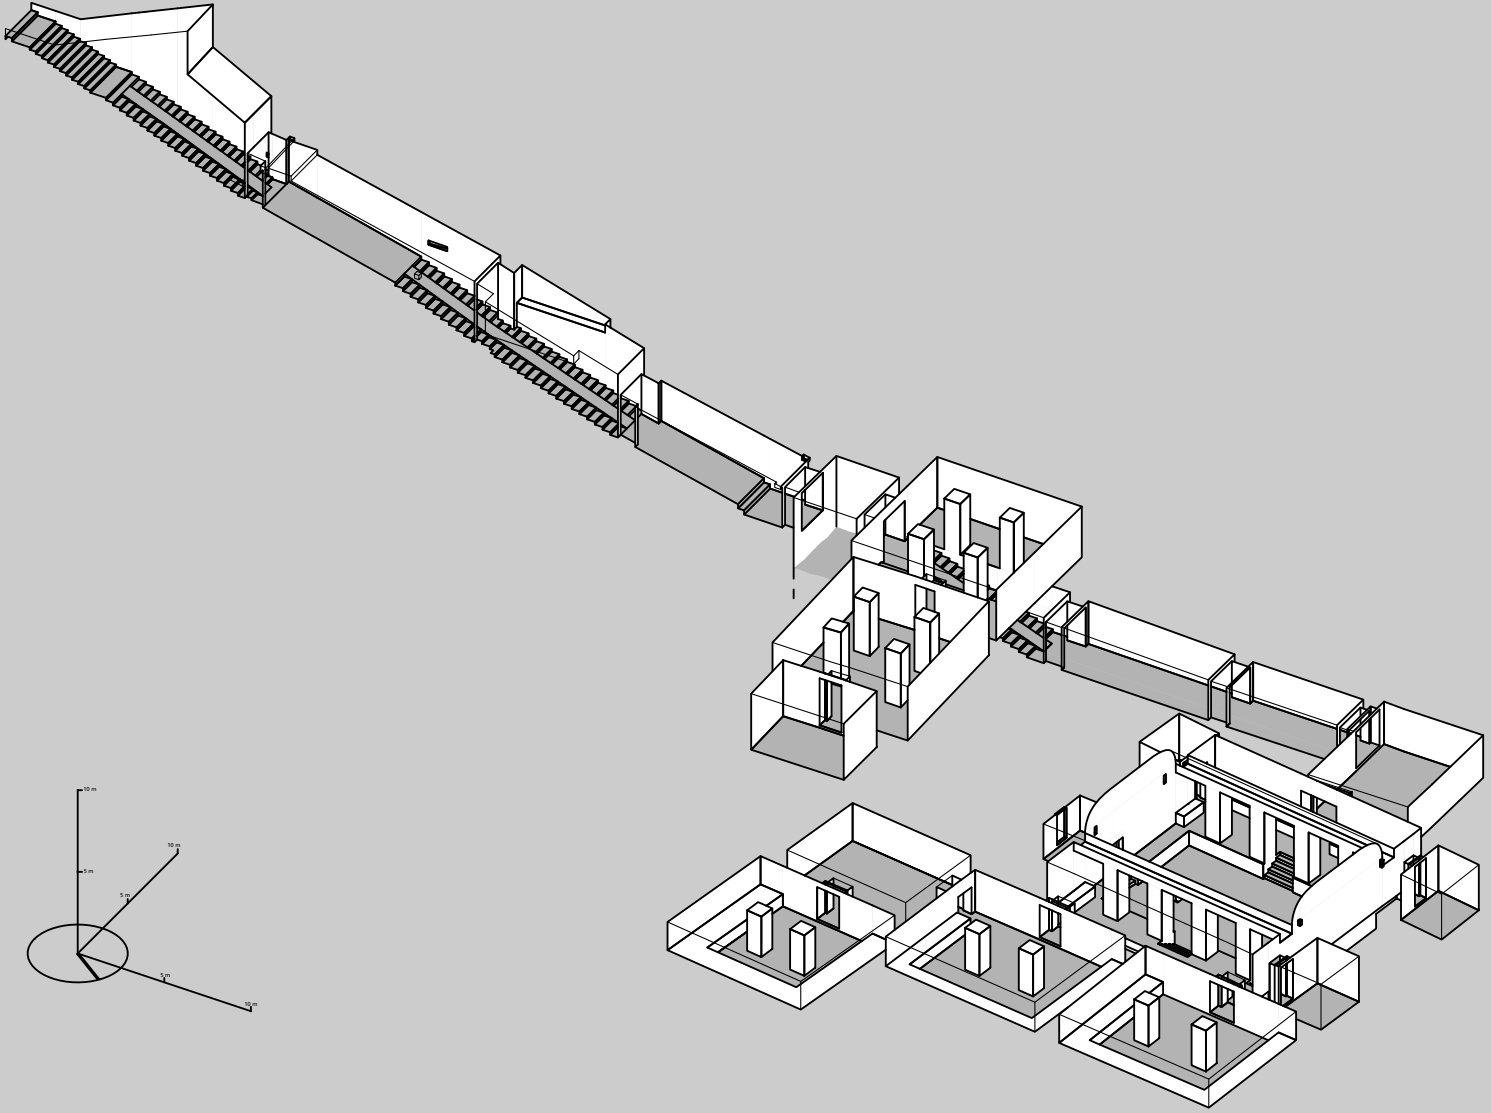
- Notes
1. Other pillars cut away at gates B to H.
  2. Slotted socket for dowel cramps to hold in place sandstone block replacements of original door pivots (at gates B to H).
  3. Traces of pillar rotund in ceiling. Recently plastered over.
  4. Clipping marks of hammer strike deposits that impeded cutting of the chamber.
  5. Red granite lid of outer sarcophagus removed here during the removal of the third sarcophagus to Tanks in Dynasty XXI.
  6. Modern concrete base for the red granite lid of the second sarcophagus.
  7. Colored blocks, part of the original (pink) for the set of sarcophagi.
  8. Modern steps.
  9. No evidence of a divided runway was found by the TMP survey, although it is shown on earlier plans (Carter, Thomas, Foster and Mace).

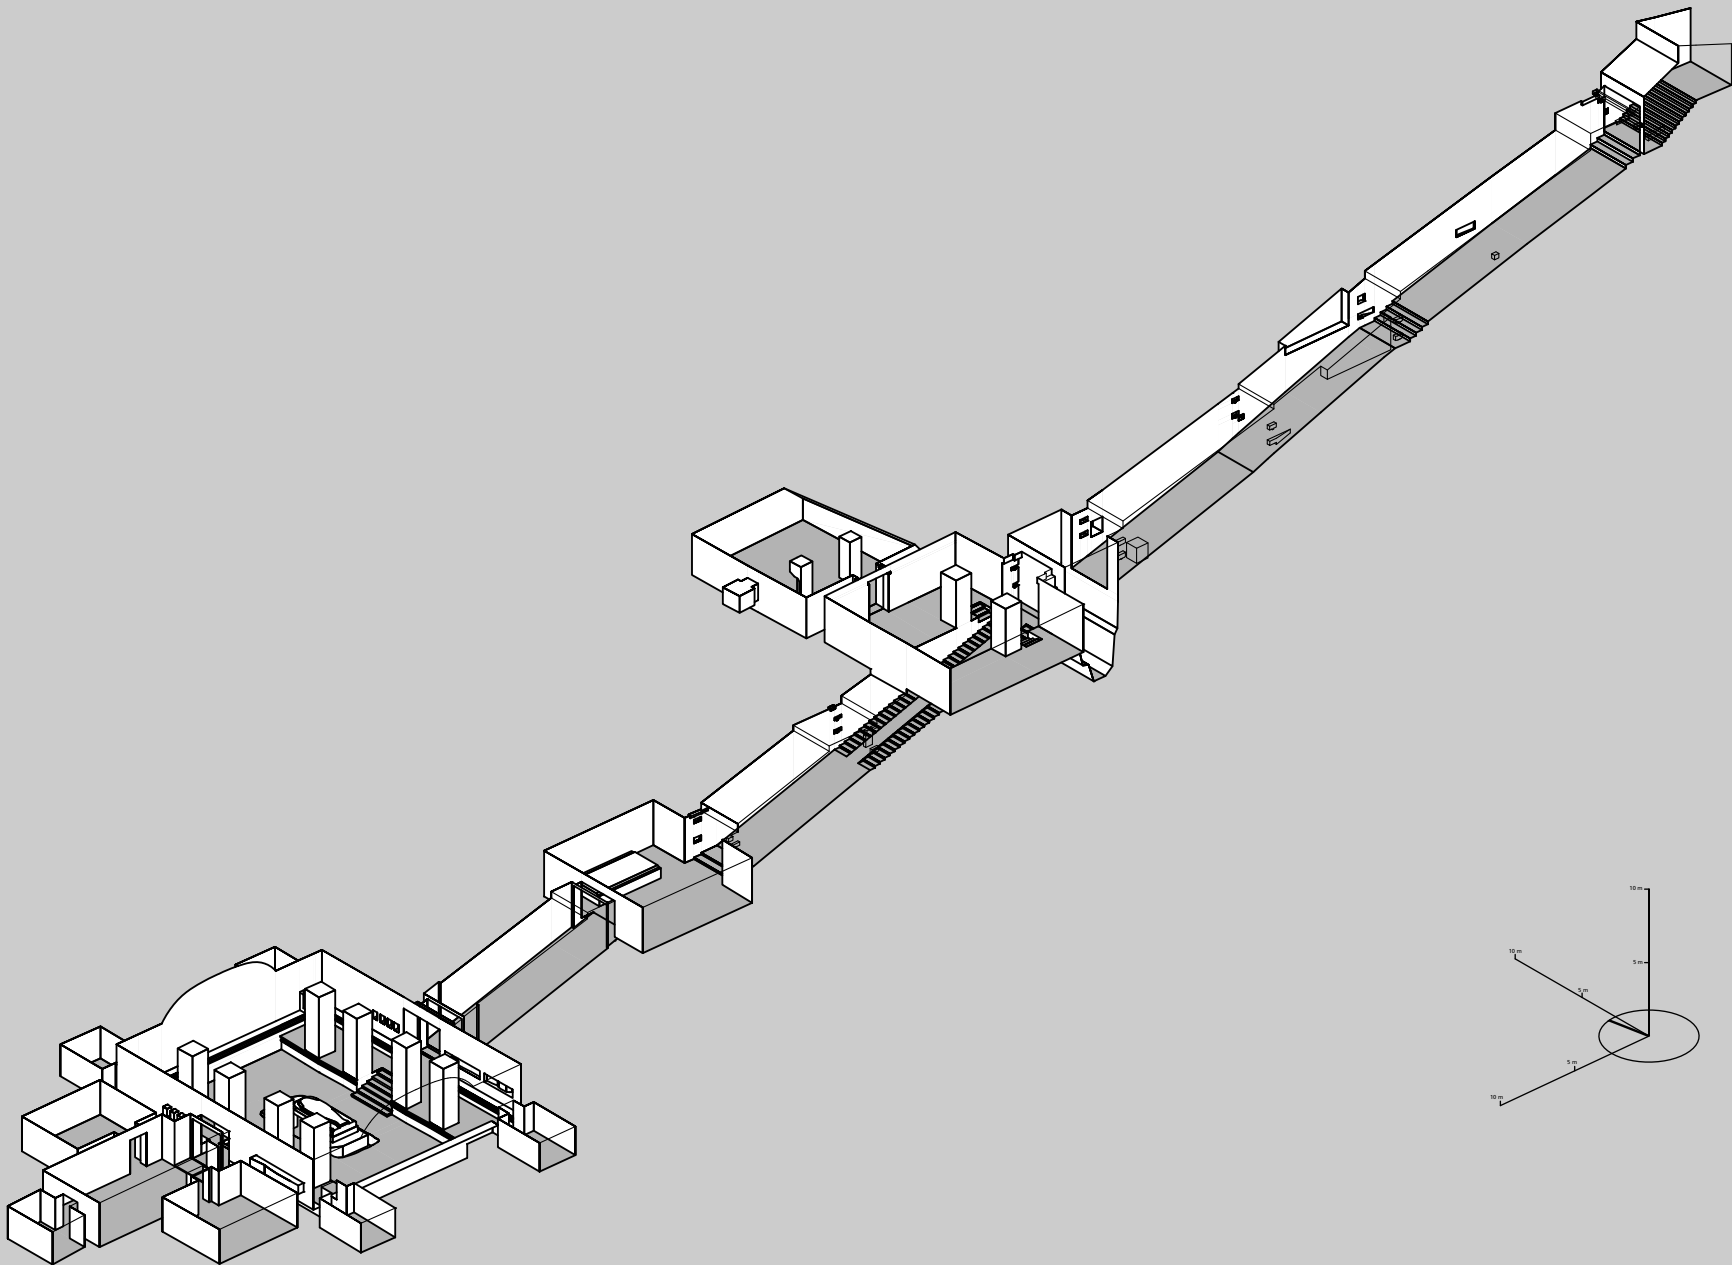
- NOTES
- 1 Made in the upper left corner of the listel where the tomb cutting broke into chamber G of KV 9.
  - 2 Sloping wall of handbuilt rubble deposits that impeded cutting of the chamber.
  - 3 Remains of the red granite outer sarcophagus box abandoned after attempted quarrying for reuse.

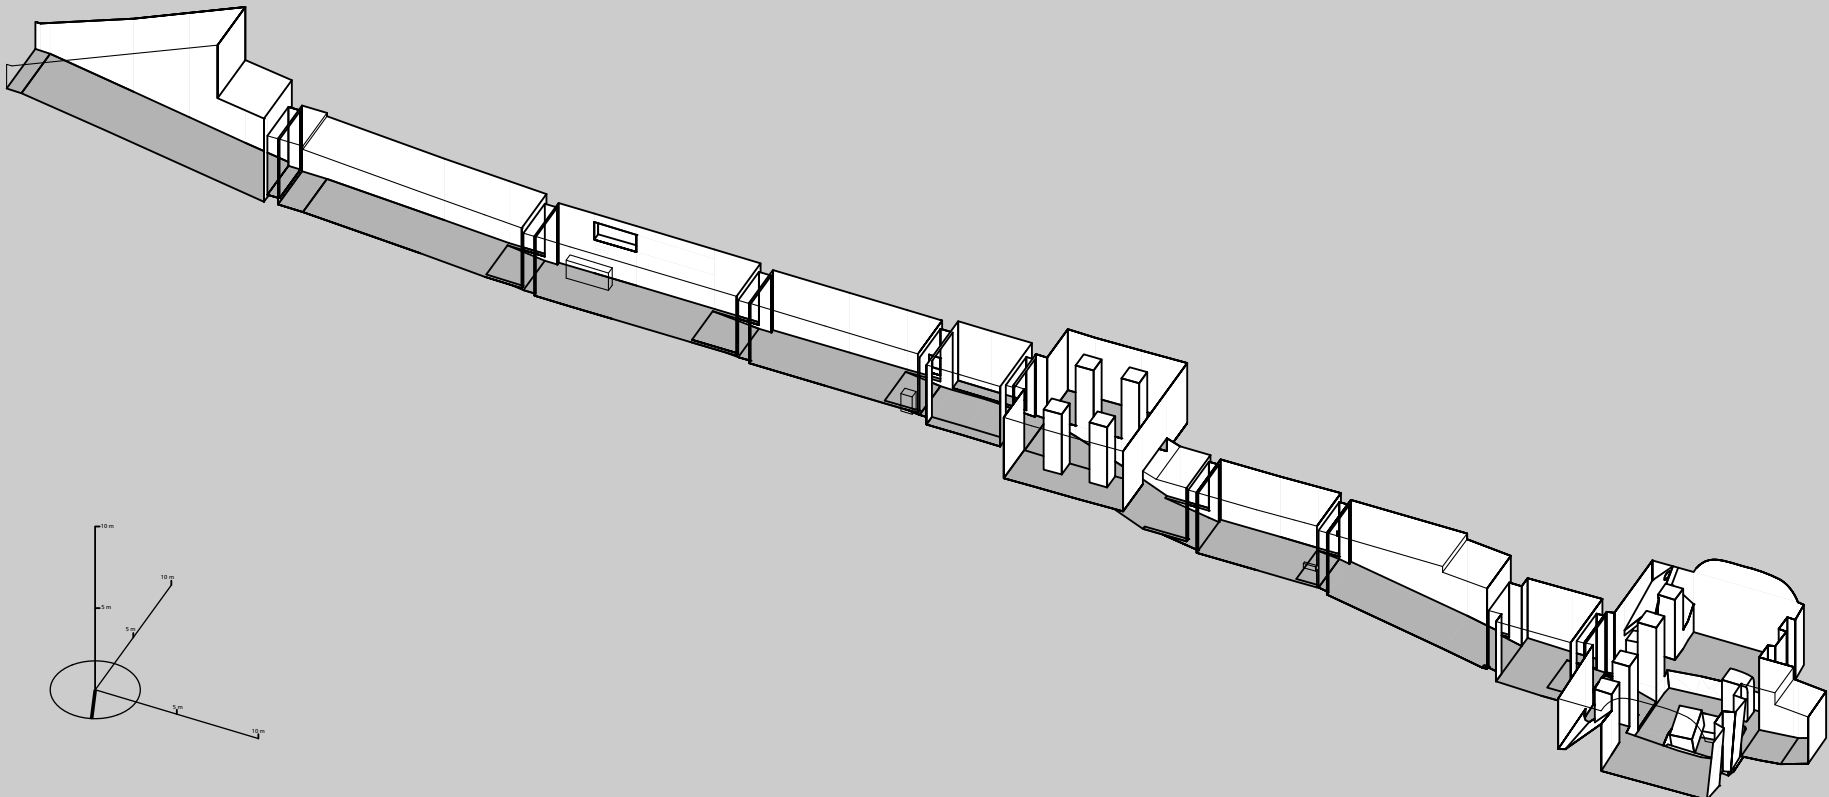
NOTES	
1	Modern lines.
2	Original line of hidden below modern retaining wall.
3	Other structures with structural ceiling or walls and pillars, as well as wall were broken into by the cutting of corridor D14 in KV 11.
4	Trace of the original ceiling, ceiling fallen in above.

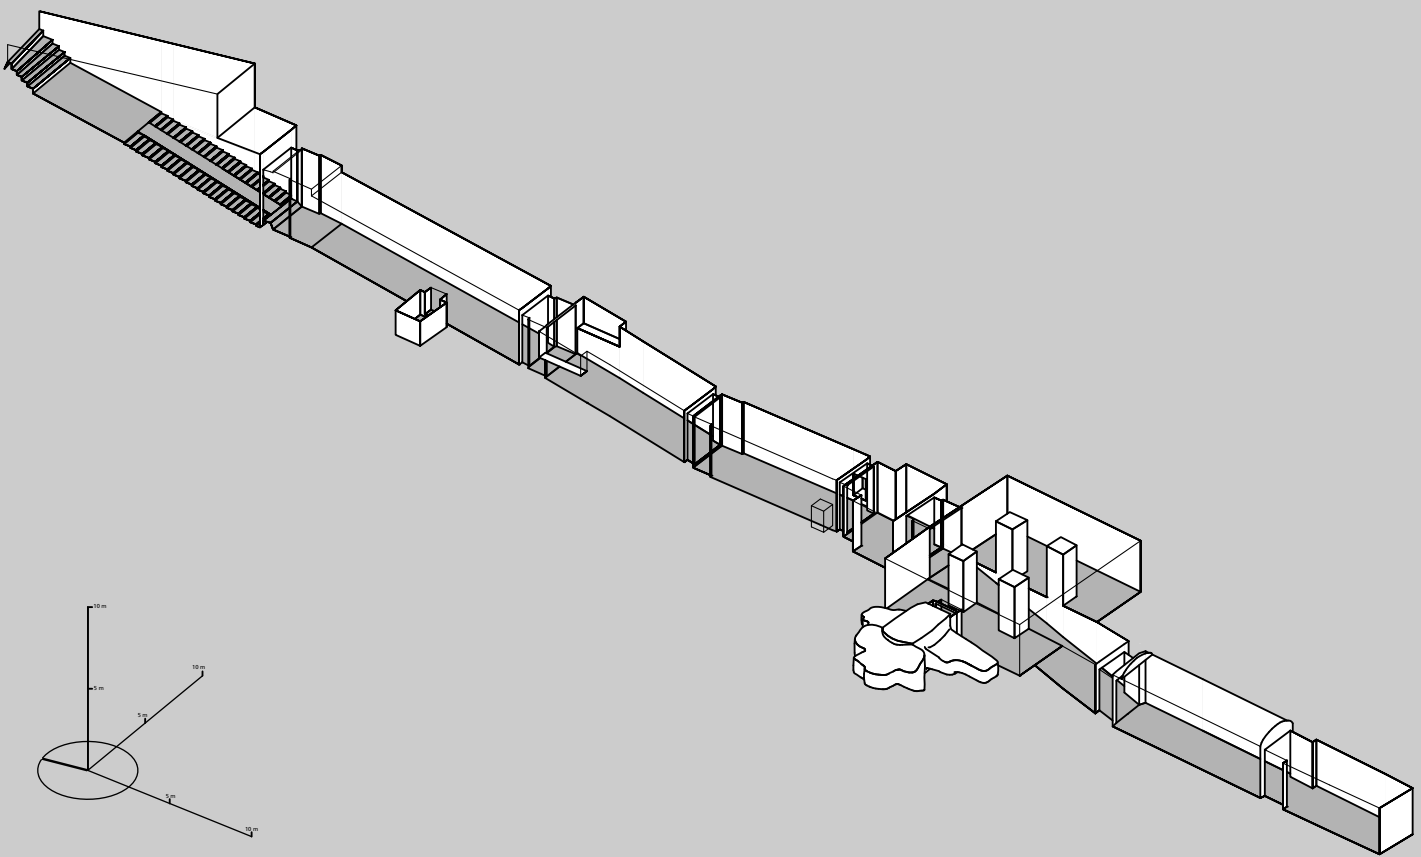
NOTES	
1	Modern steps.
2	Pillar and column-headed columns.
3	Undetermined doorway that breaks into side chamber Fa of KV 10.

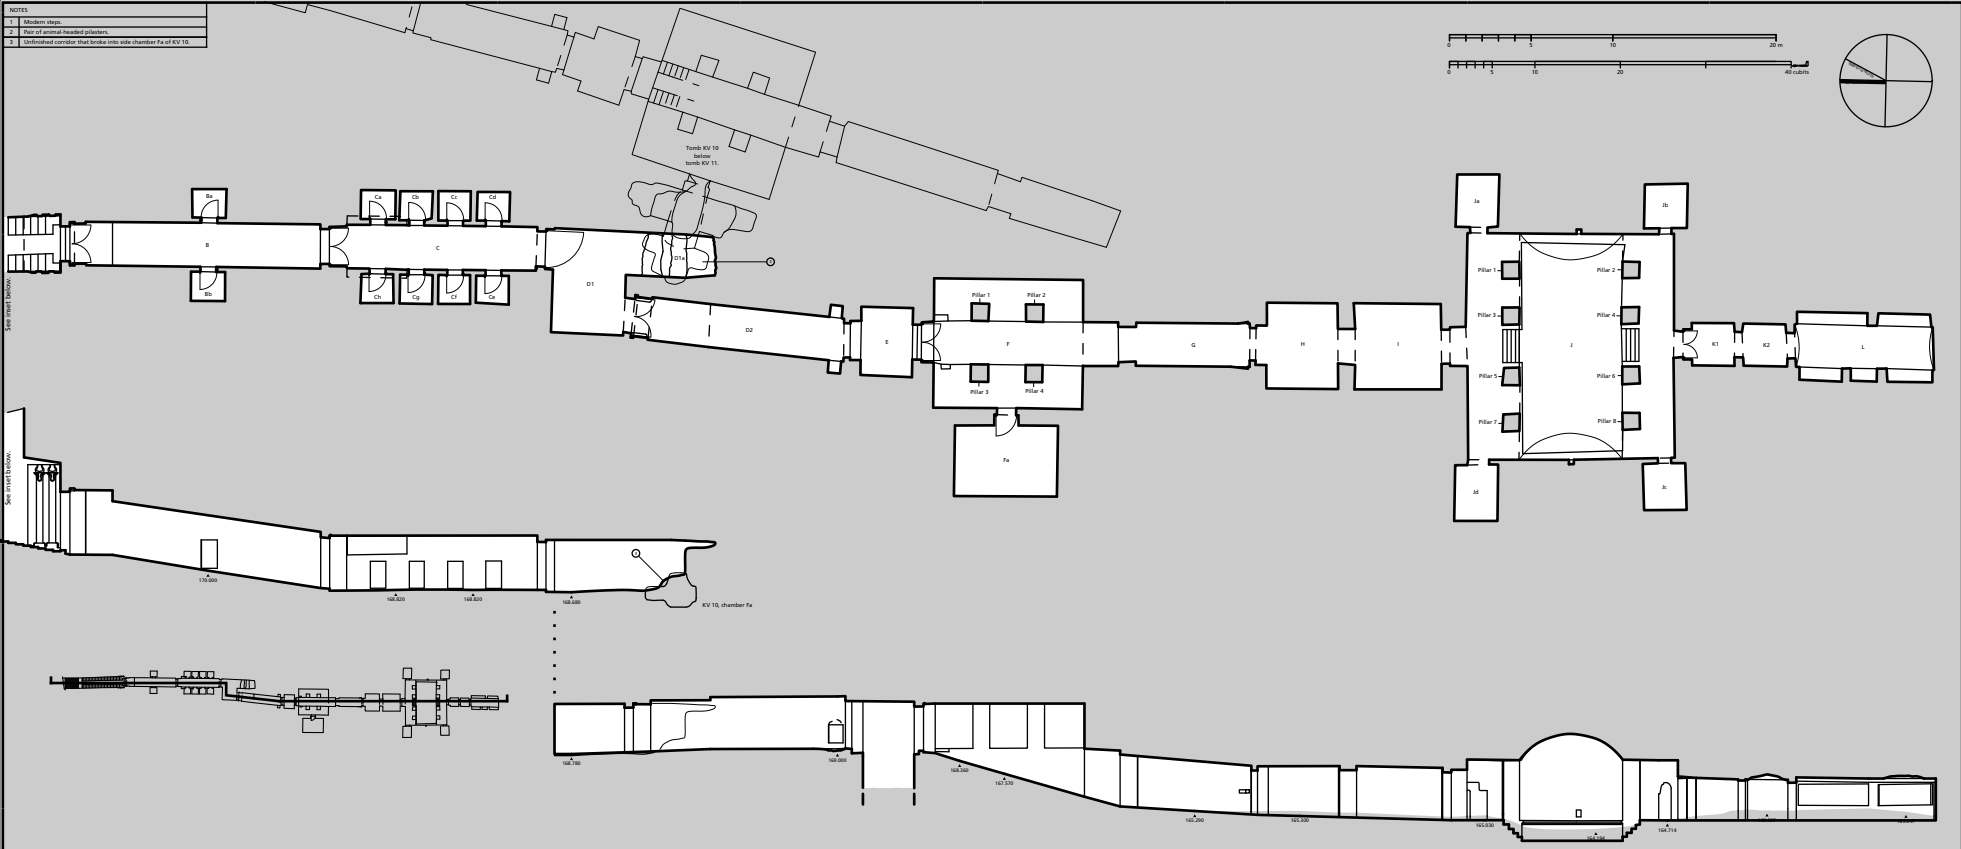
KV 11 - Ramesses III  
 Plan, sections 1:25  
 Dyn. XX  
 Sheet 56/72 - KV 11 (1/2)

Rooms Ba - B - Bb

Rooms Ca - C - Ca

Rooms Cg - C - Cb

Rooms Cf - C - Cc

Rooms Ce - C - Cd
