Valley of the Kings & West Valley  
Plan 1:1,500 Contour Interval 10m

Sheet 1/72 - KV & WV (1/1)

Theban Mapping Project  
**KV 1 - Ramesses VII Dyn. XX**  
 Plan, sections 1:125, Axonometric  
 Sheet 7/72 - KV 1 (1/1)

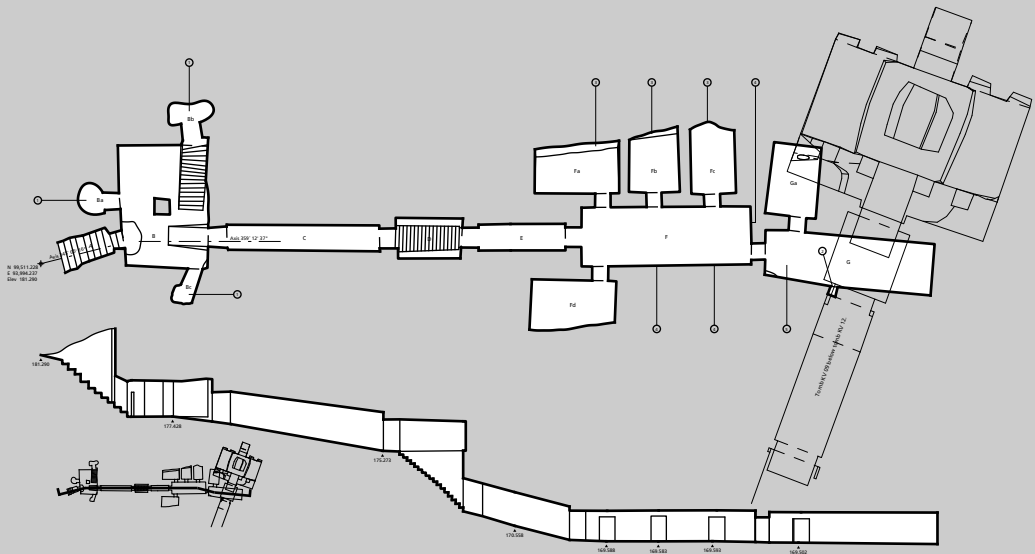
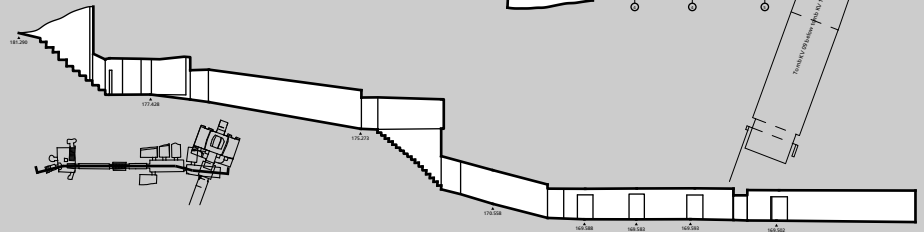
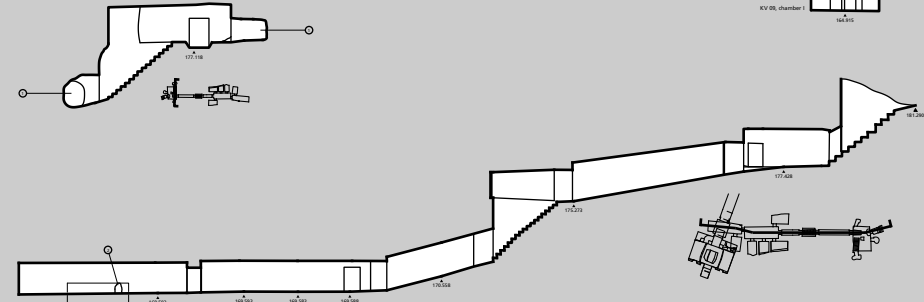
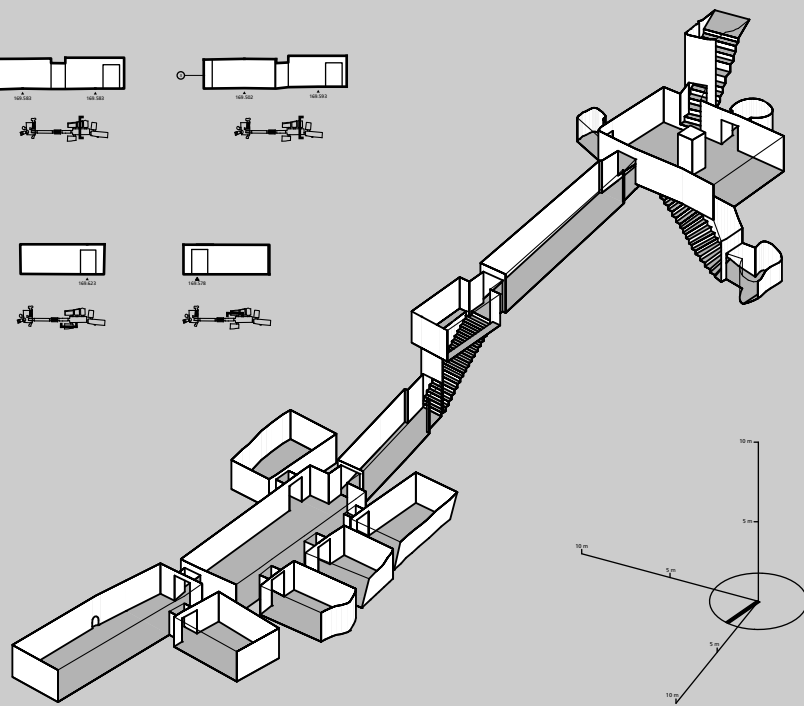
# KV 13 - Bay Dyn. XIX

NOTES	
1	Unfinished cutting of side chamber.
2	Hole in bottom of the wall where the cutting of corridor H in KV 9 broke through.
3	Stepping slab of hardened calcite deposits that impeded cutting of the side chamber.
4	Outline of corner gable drawn on wall in black paint.
5	Chamber receives wall-plaster of stone gable drawn on wall in black paint, but their locations are unadorned.

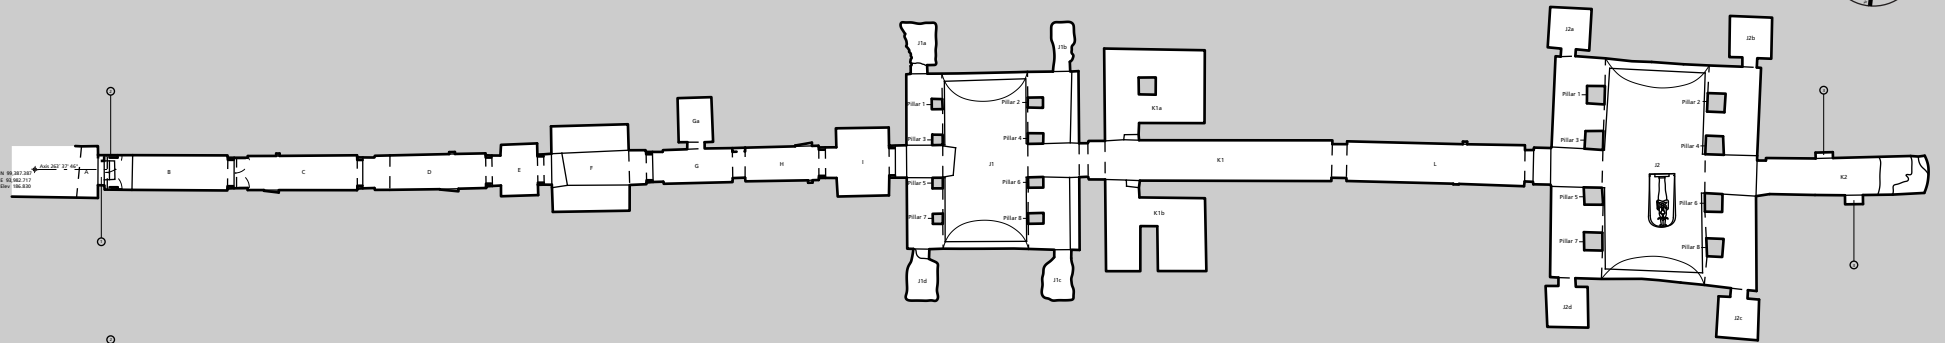
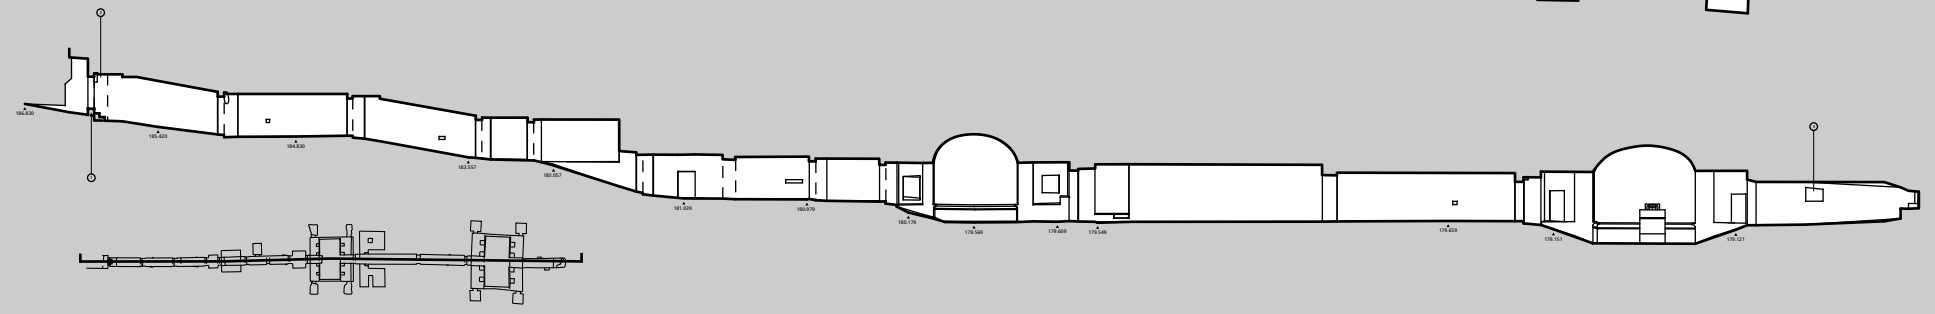
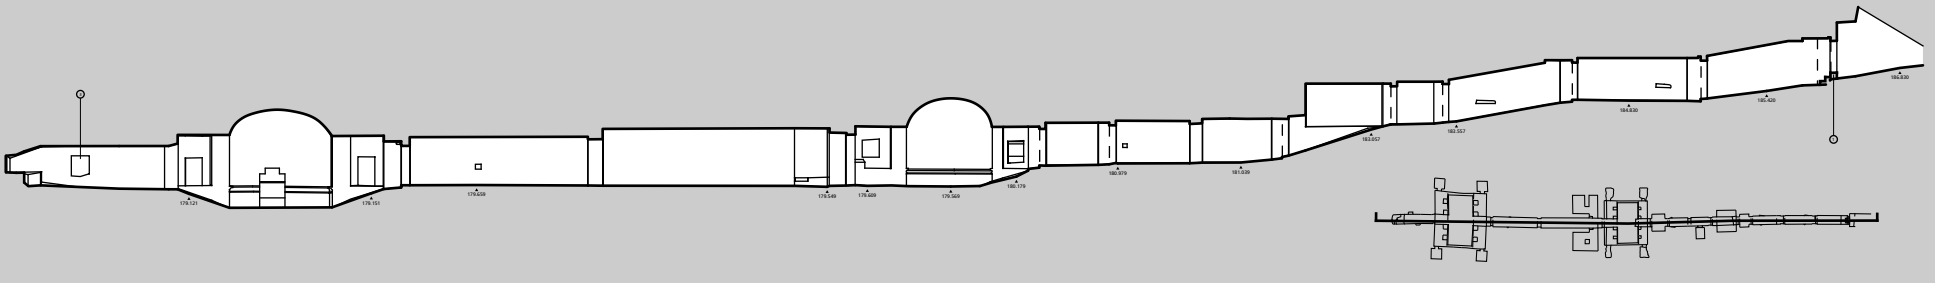
KV 14 - Tausert Dyn. XIX  
 and Setnakht Dyn. XX  
 Plan, sections 1:125  
 Sheet 30/72 - KV 14 (1/2)

NOTES
1. Modern lines.
2. Clear paths cut away at gates B to J.
3. Unfinished cutting of gate.

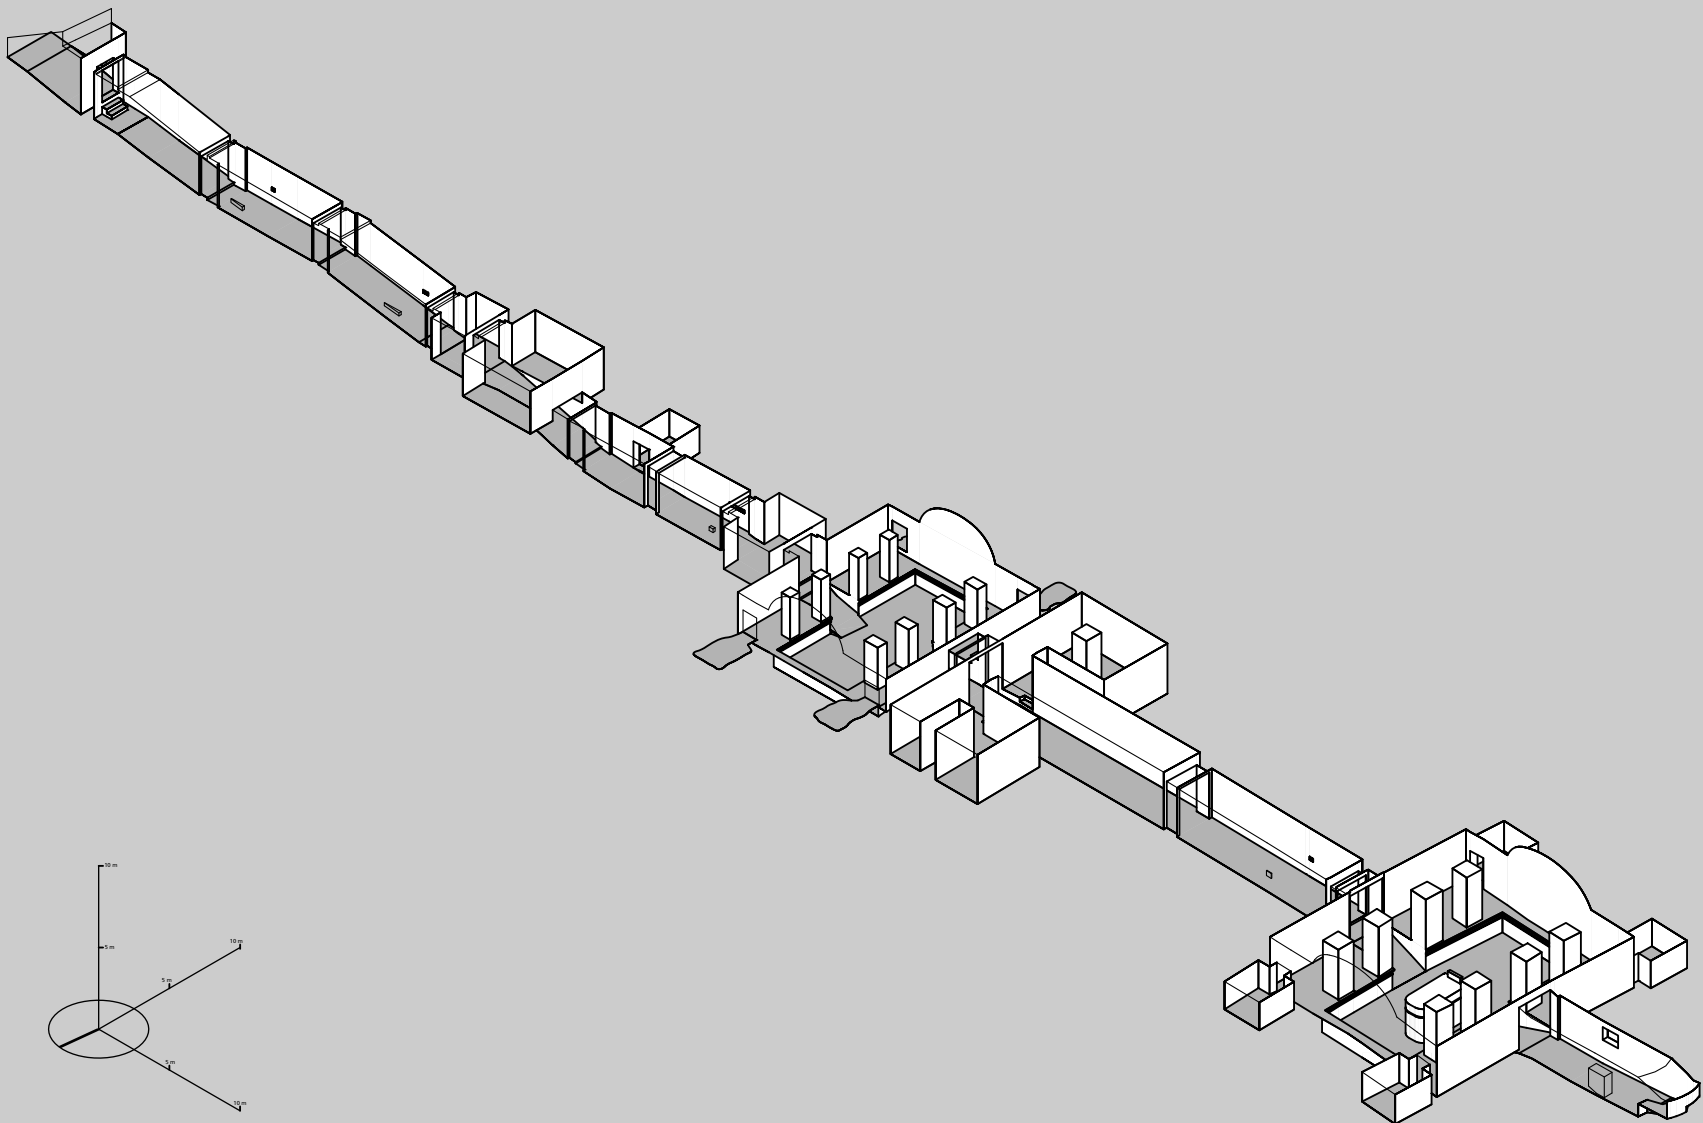
NOTES	
1.	Modern step at tomb entrance.
2.	Parts of pylon not easy to broken. Modernly filled with plaster.
3.	Disturbed cutting of pylon.
4.	Disturbed cutting of pylon.
5.	Sarcophagus lid now set on modern supports.

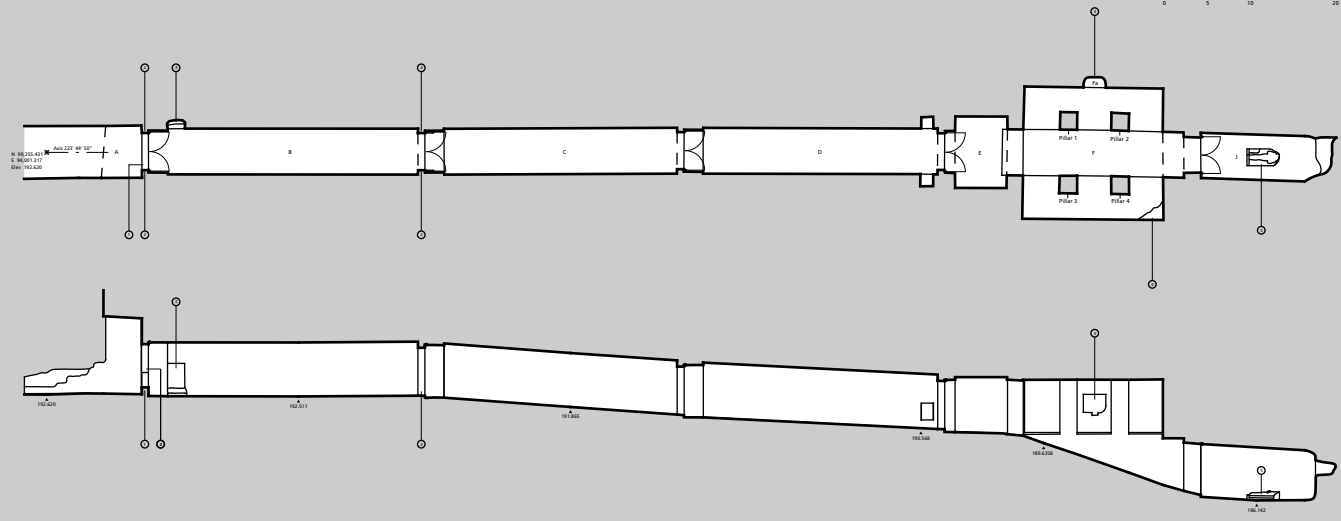
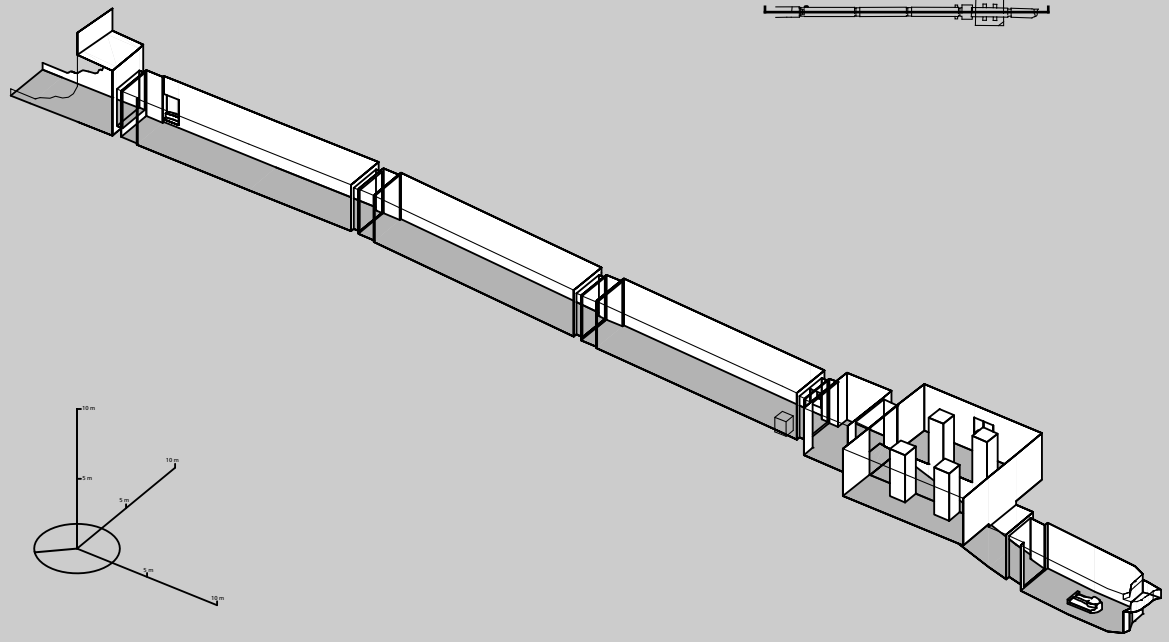
NOTES	
1	Modern steps.
2	Modern brick jambs.
3	Modern step.

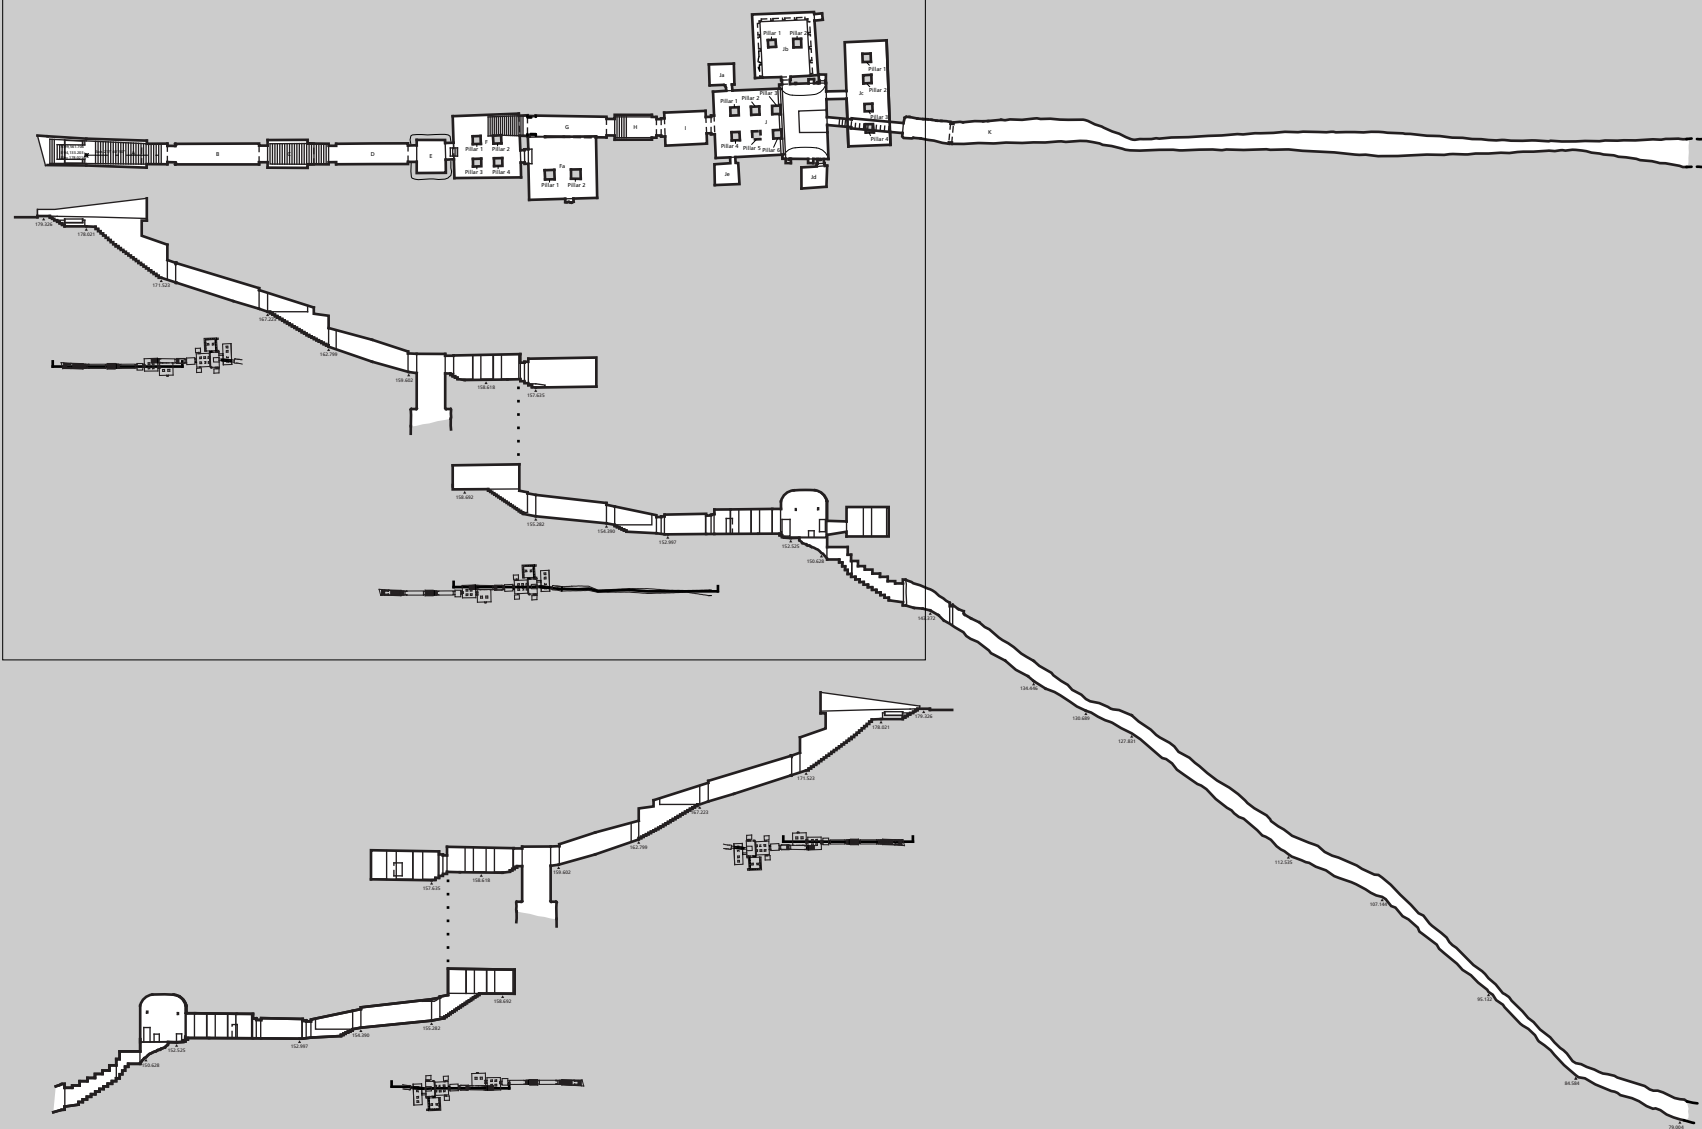
NOTES	
1	Modern steps and benches in tomb entryway.
2	It cannot yet be determined if the widening of the lower part of the shaft was intentional.
3	Modern steps.
4	Break rear floor into corridor C.
5	Disturbed pattern of raised area.
6	Decorated panels removed by Champollion, now in Paris and Florence.
7	Pillar missing, one face in Berlin.
8	Bottom of bench broken away.
9	View line of pillar cut away.
10	Modern brick arch replacing broken gate and supporting wall above.
11	Modern steps and brick arches in tunnel.

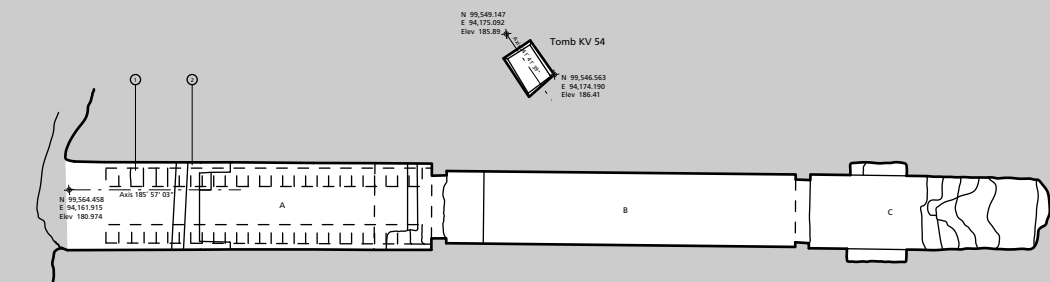
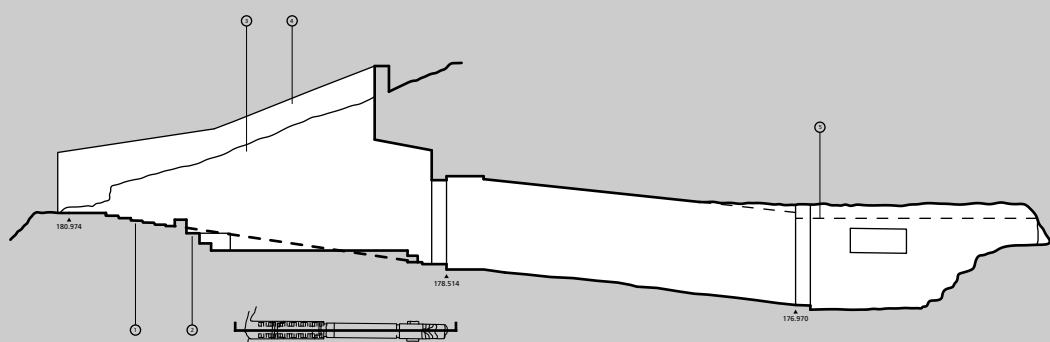
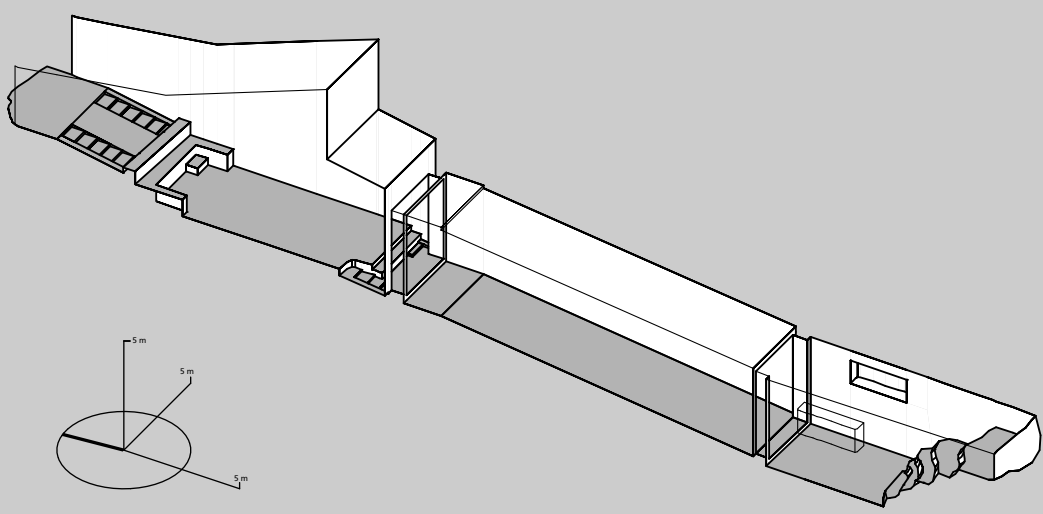
**Tudman Mapping Project**  
**KV 18 - Ramesses X**  
**KV 54 - ca. Tutankhamen**  
 Plan, section 1:125, Axonometric  
 Courtesy: Mission Siphth-Kameses X, Universitat Basel.  
**Dyn. XX**  
**Dyn. XVIII**  
 Sheet 37/72 - KV 18, 54 (1/1)

NOTES	
1	Modern threshold.
2	Steps leading down to KV 60, now covered with wooden sheeting.
3	Burial pit, once covered with stone slabs.

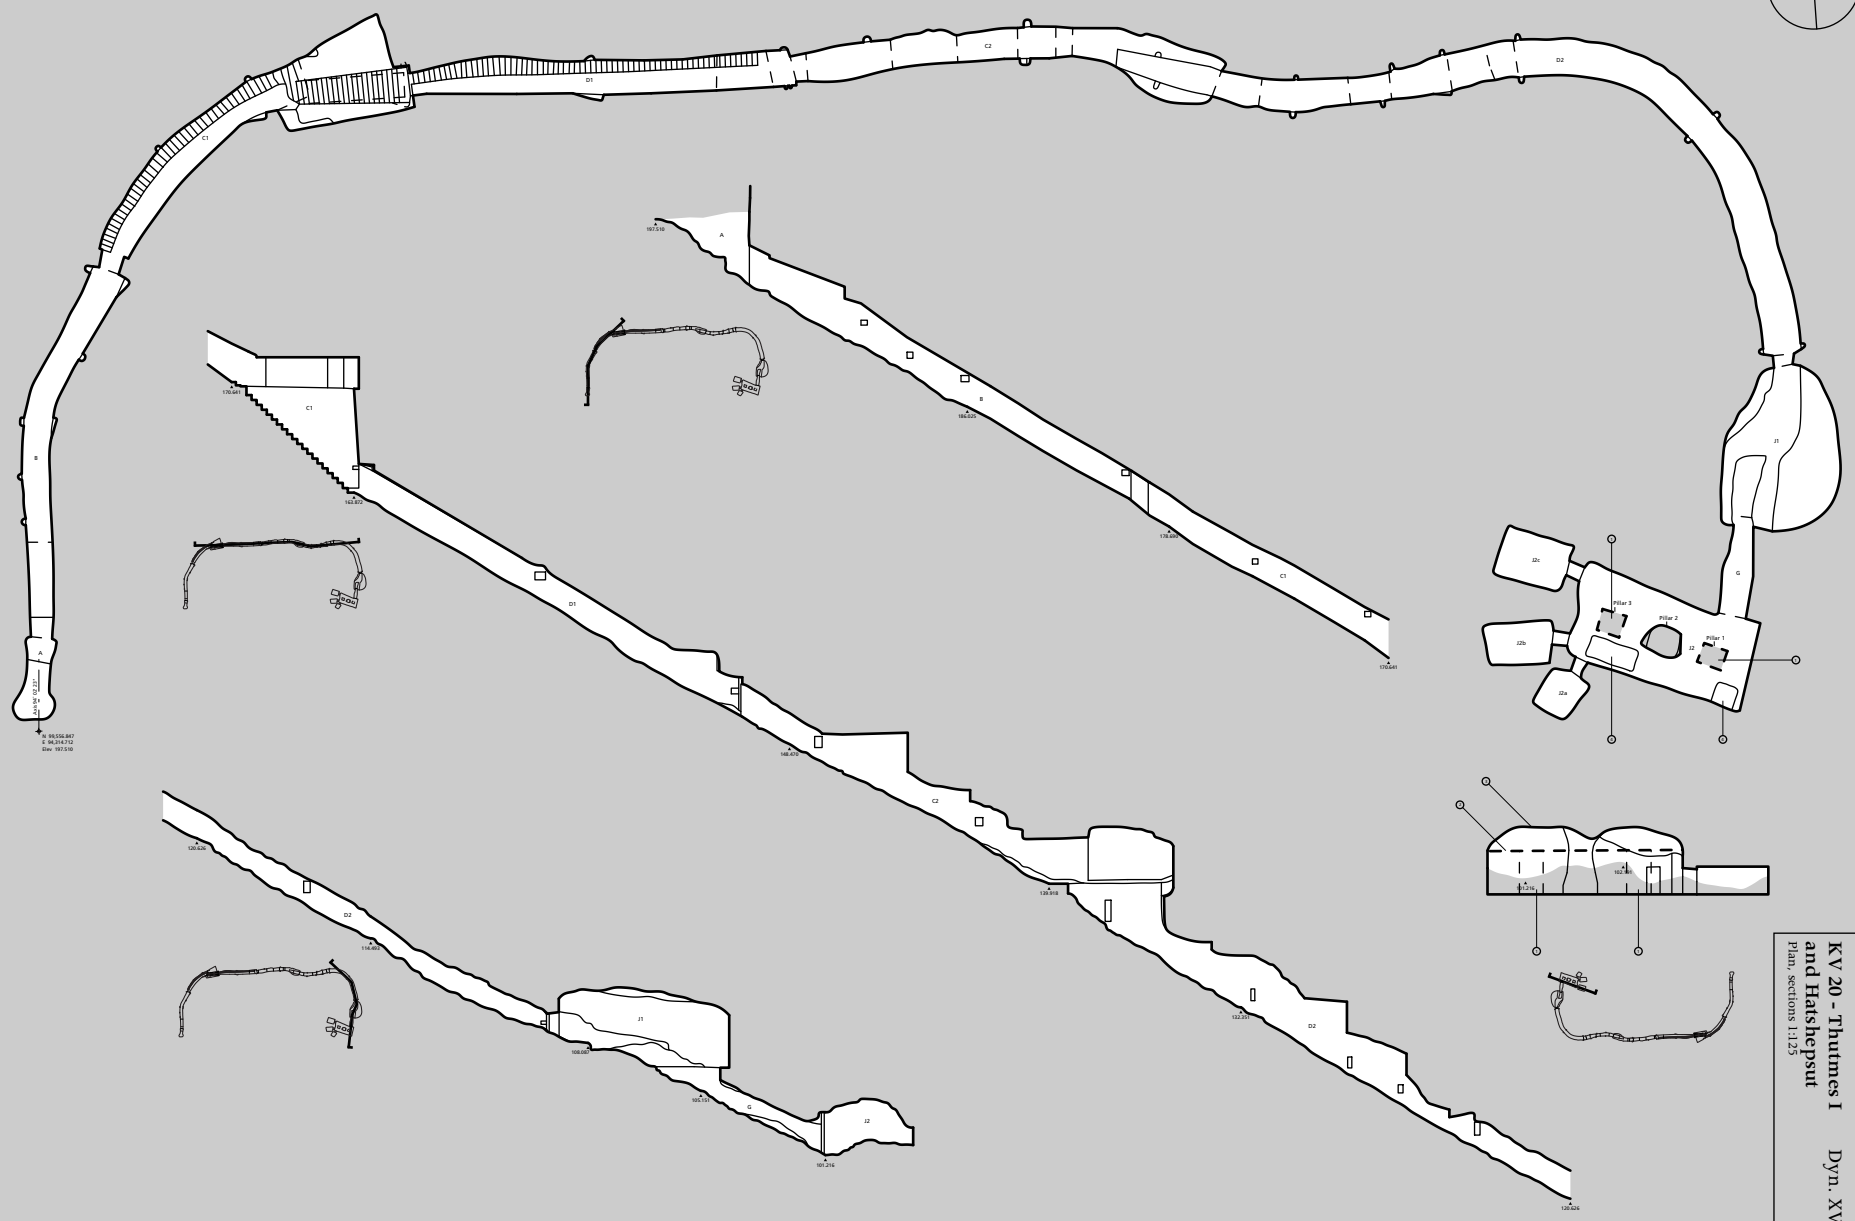
KV 20 - Thutmose I and Hatshepsut  
 Plan, sections 1:125  
 Dyn. XVIII  
 Sheet 39/72 - KV 20 (1/2)

NOTES	
1	Columns not seen by the TMP but reported by Carter.
2	Approximate line of original ceiling.
3	Collapsed ceiling.
4	Plan not seen by TMP but shown in Banister's plan.

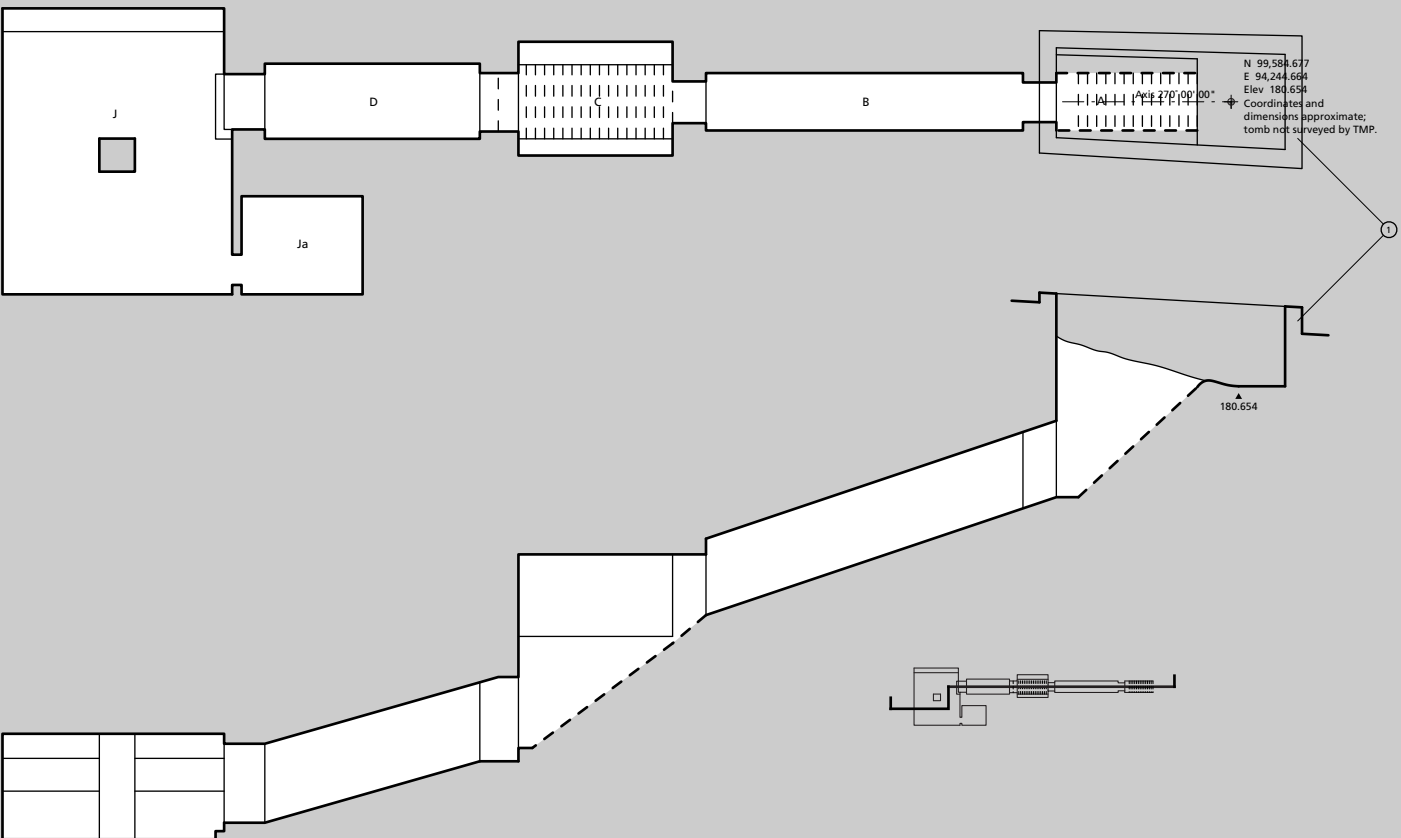
Sheet 41/72 - KV 21 (1/1)

- NOTES
1. Rectangular brick niche in yellow.
  2. Rectangular pit, possible emplacement for missing sarcophagus. Figure: No trace of the box was found, but the Wrocław University museum has re-assembled the lid fragments.
  3. Pit possibly intended for the missing sarcophagus chest.

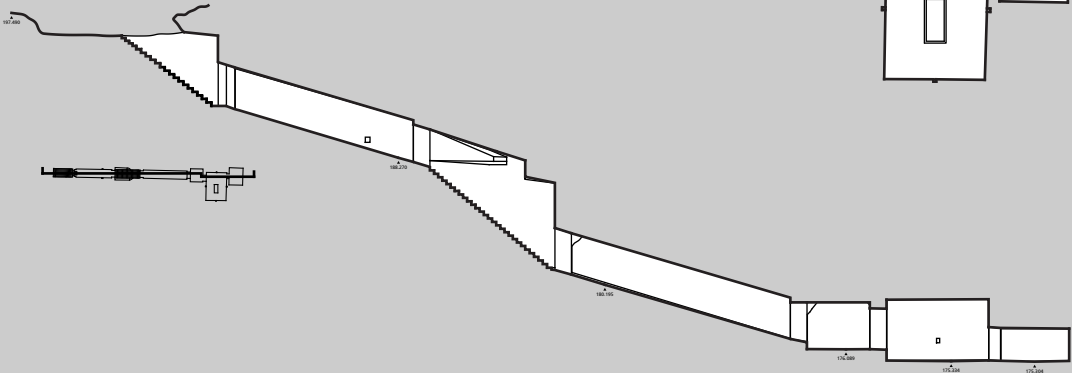
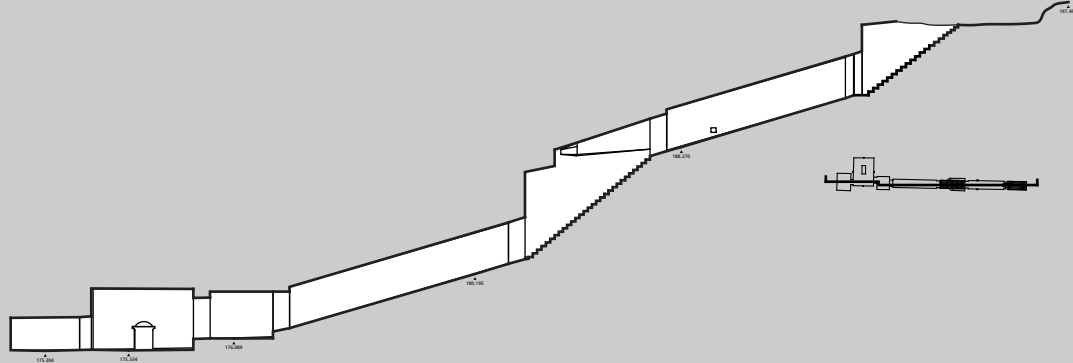
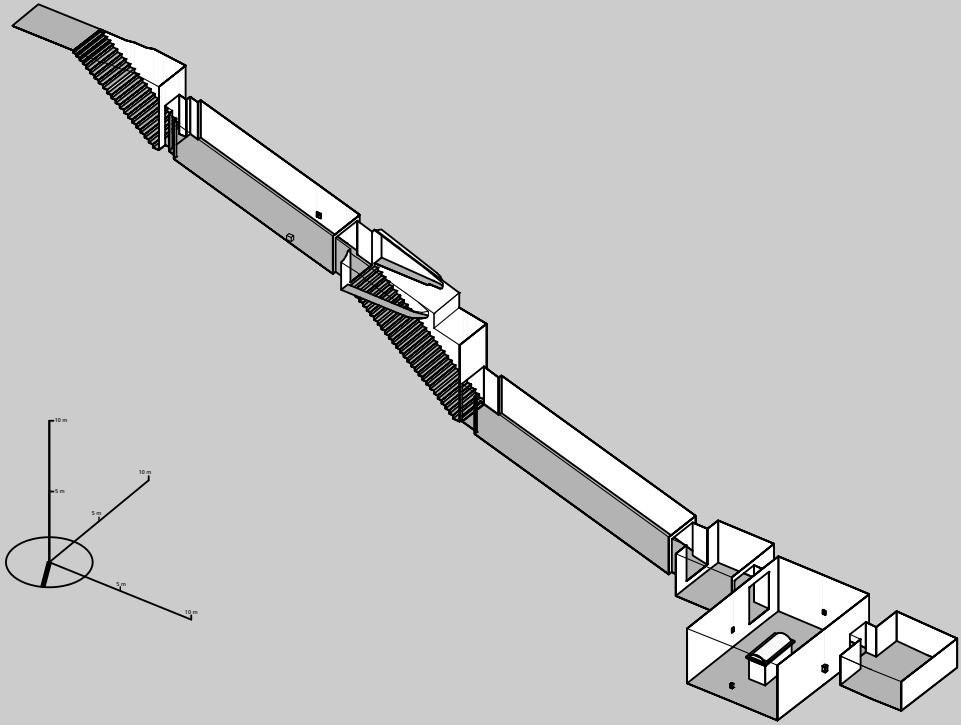
NOTES	
1	Layer of compacted gravel; excavation tunnelled through this debris to reach the tomb entrance.
2	Rubble retaining wall.
3	Remains of modern blocking.
4	Original slope of hillside.
5	Edge of well-cut wall.
6	Presumed slope of hillside, buried beneath compacted gravel.
7	Original edge of overhang.
8	End of finished floor cutting.

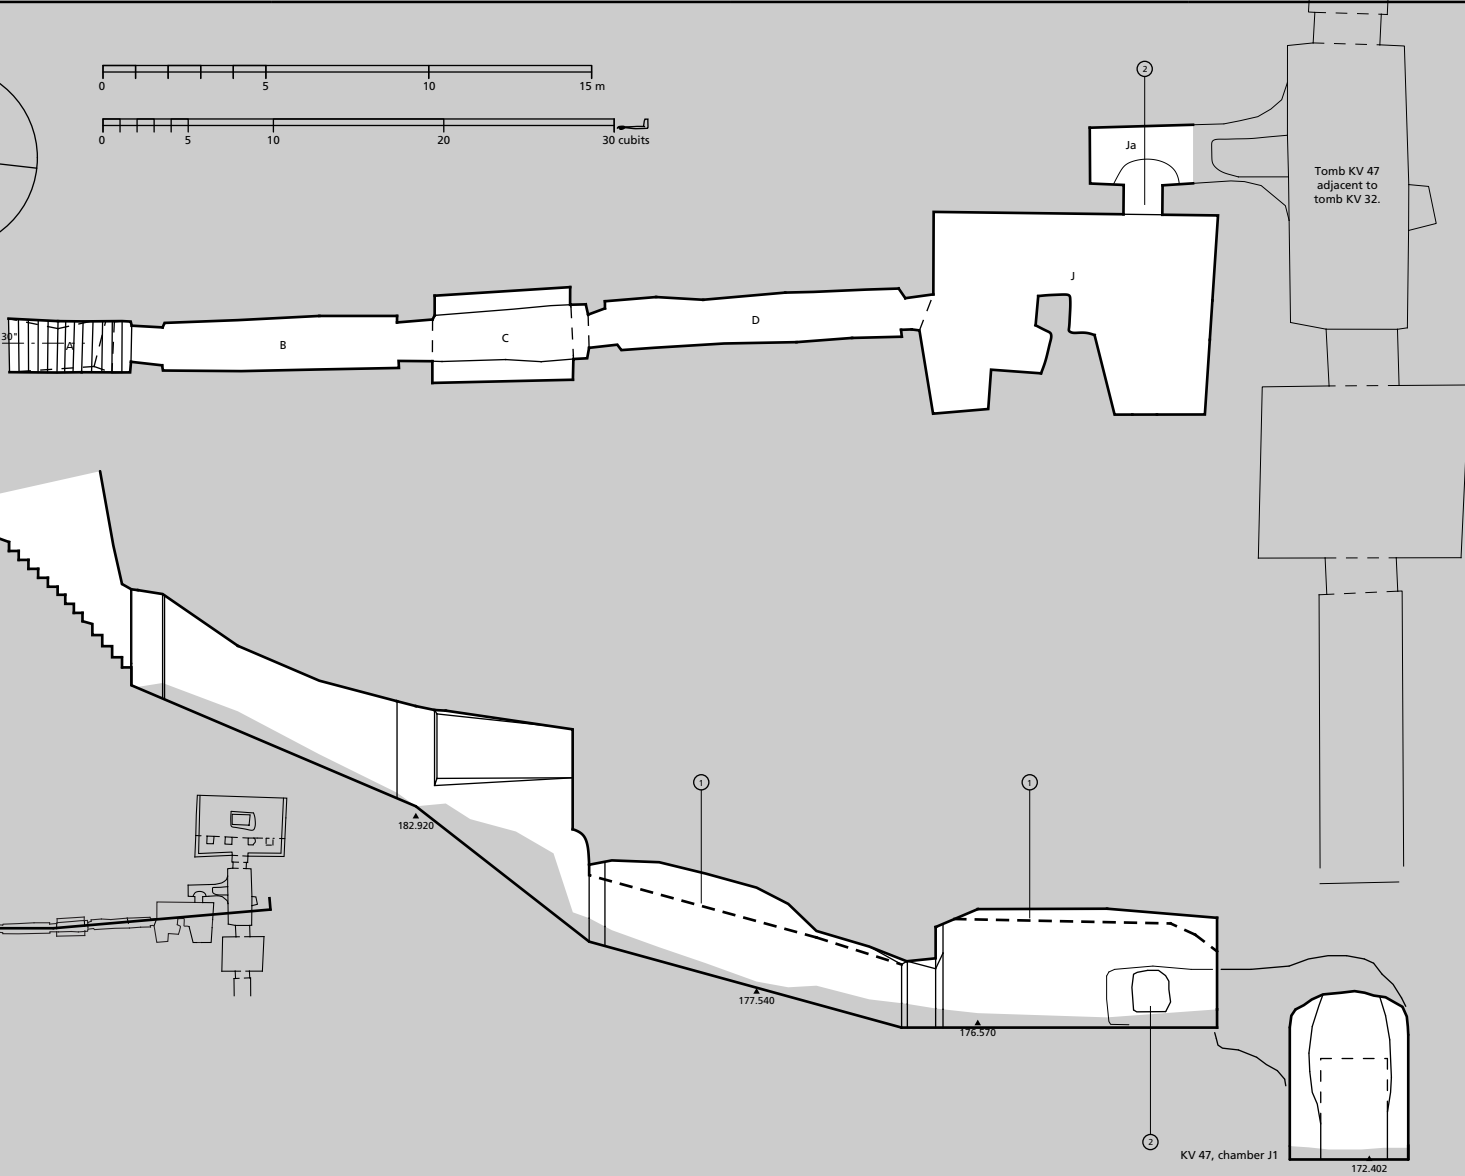
**KV 32**

NOTES	
1	Traces of the original ceiling; ceiling fallen in above.
2	Breakthrough from KV 47.

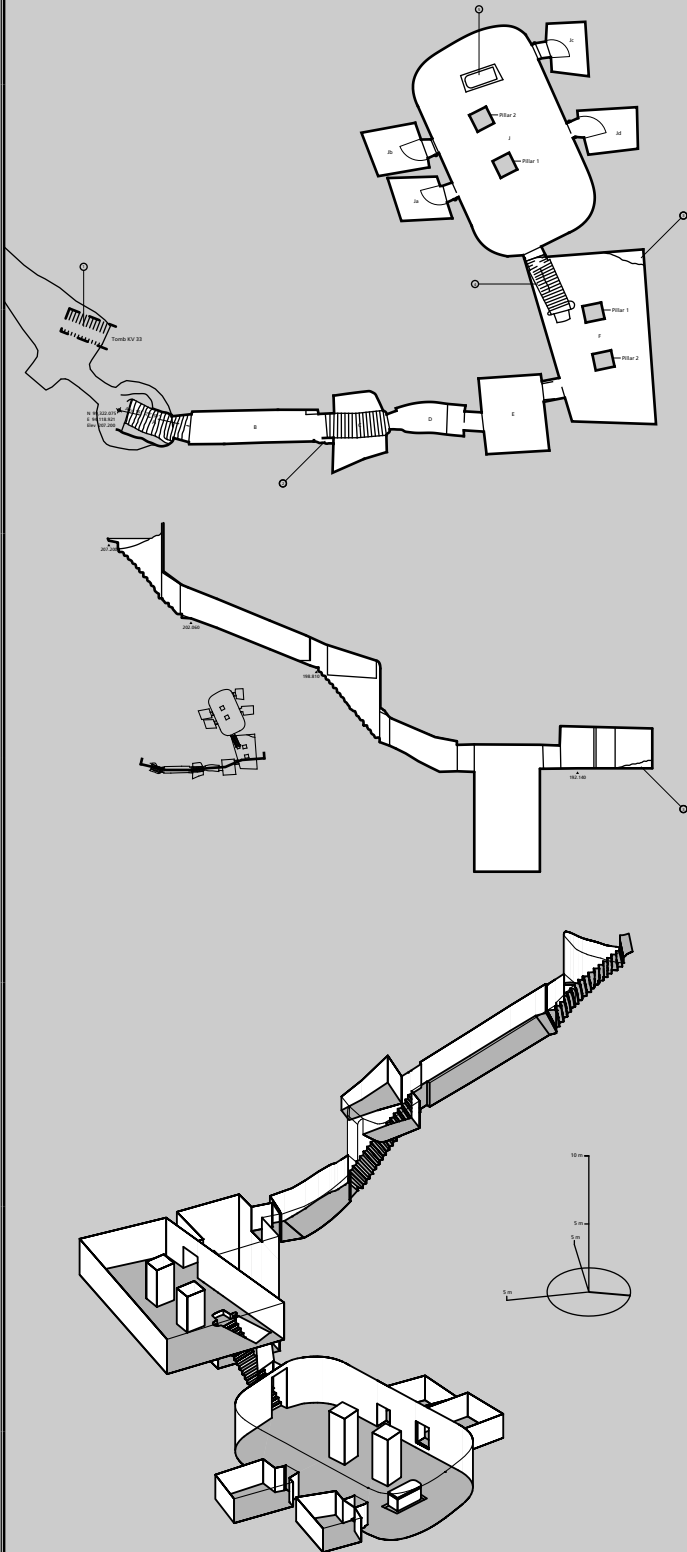
**KV 33** Dyn. XVIII  
**KV 34 - Thutmes III**  
Plan, sections 1:125, Axonometric

Notes	
1	Approximate location of KV 33, covered with modern construction.
2	Roofs not built.
3	Unexcavated portion of floor.
4	Part of main building.
5	Excavation made on limestone blocks placed in pit.

NOTES	
1.	Modern concrete shelter protecting entrance from falling rock.
2.	Precinct stairs badly damaged.
3.	Broken steps.
4.	Unexcavated debris.
5.	Sarcophagus rests on limestone pflith blocks placed in pit.
6.	Shallow pits in floor.

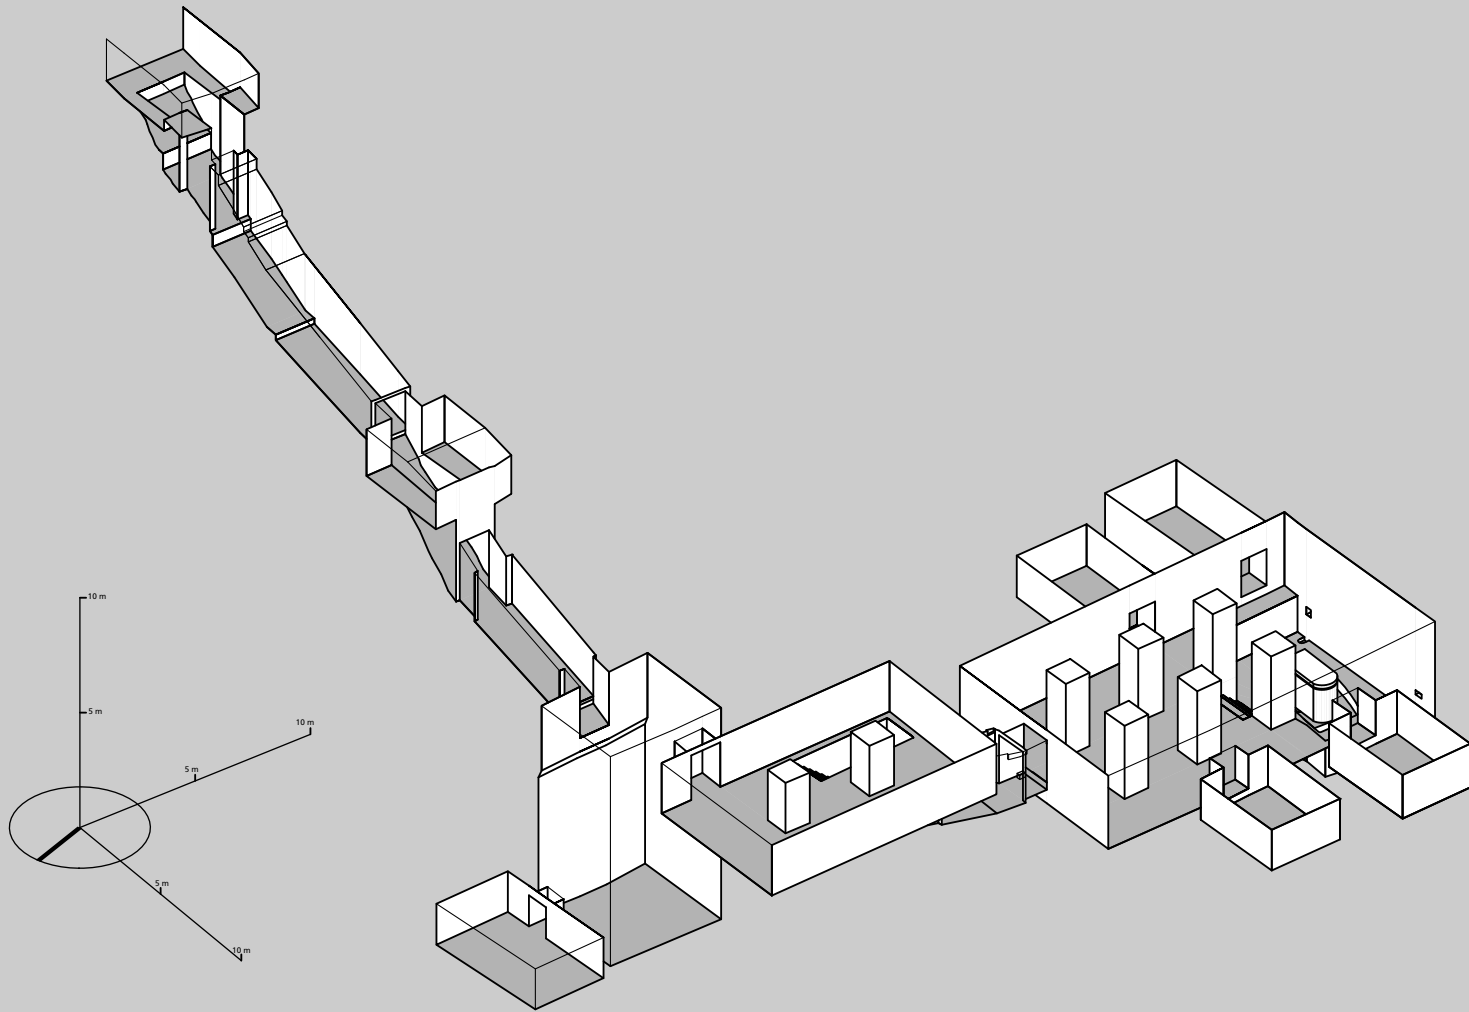
NOTES  
 1 Decorated recess cut into the rock face above the tomb entrance. It is probably of Dynasty 19 or 20, and traces of Hathor painted on plaster can be seen on the northeast wall.

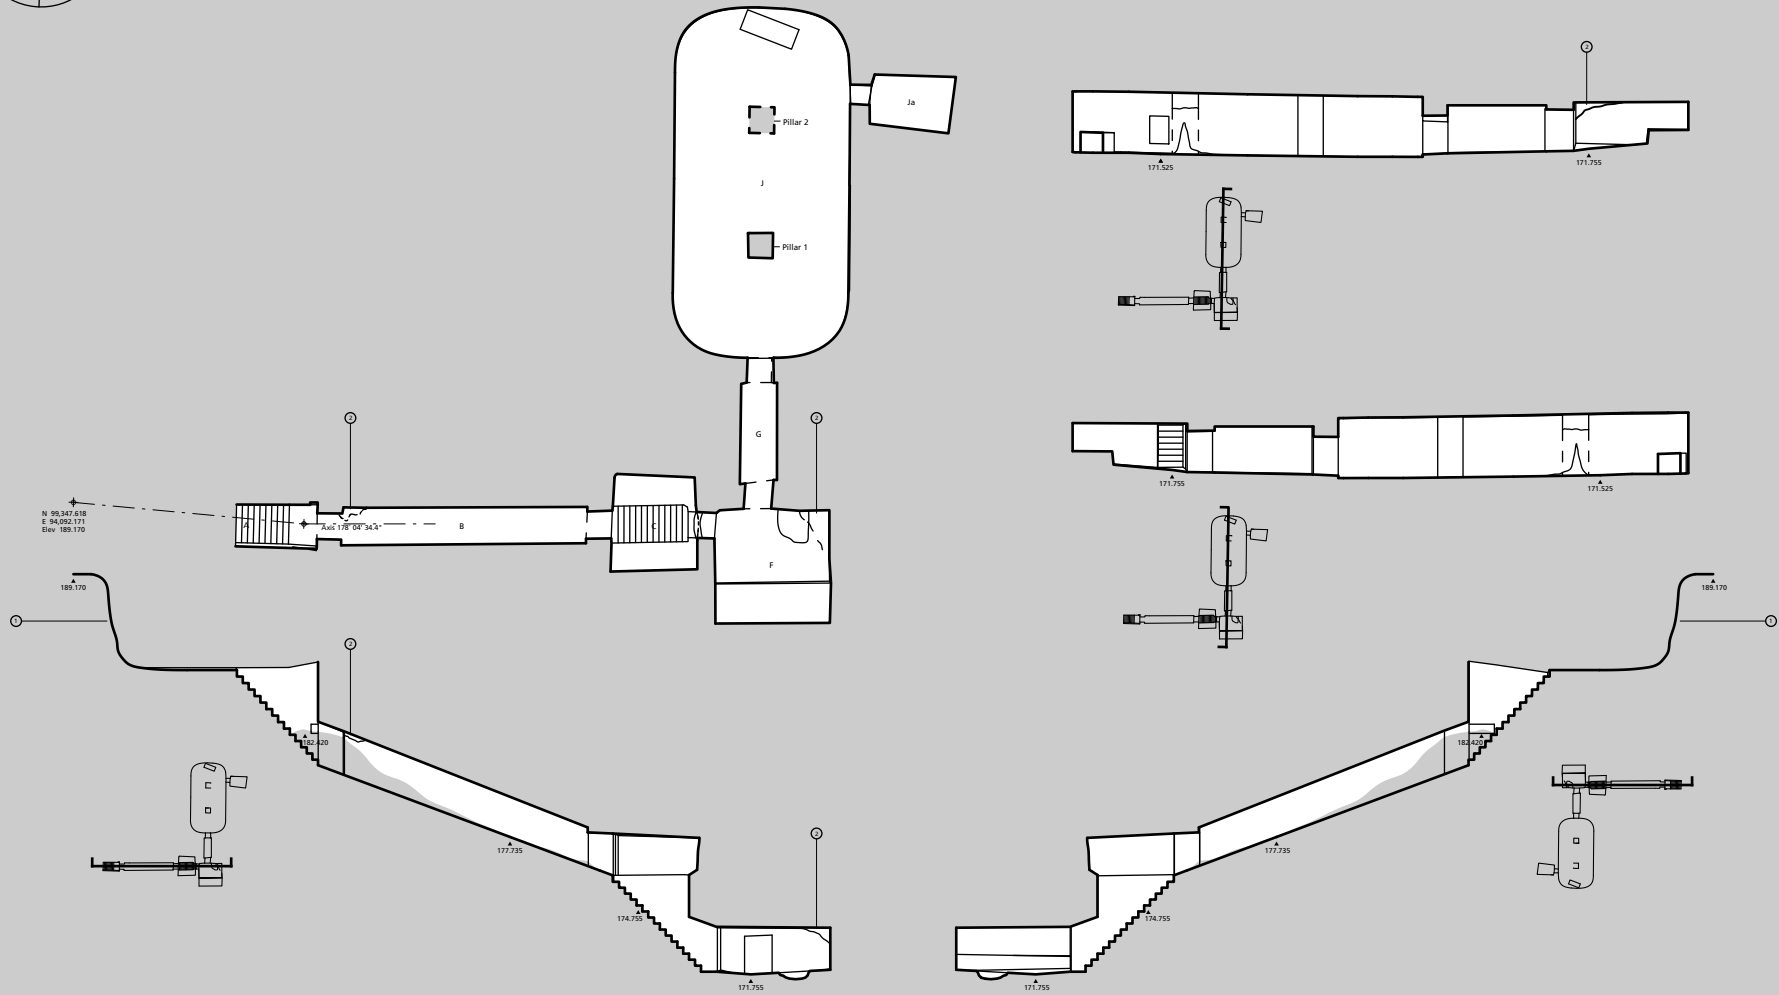
KV 42 - Dyn. XVIII  
 Hatshepsut Meryet-Ra  
 Plan, sections 1:125

NOTES	
1	Modern rubble retaining wall.
2	Unfinished cutting of ceiling.

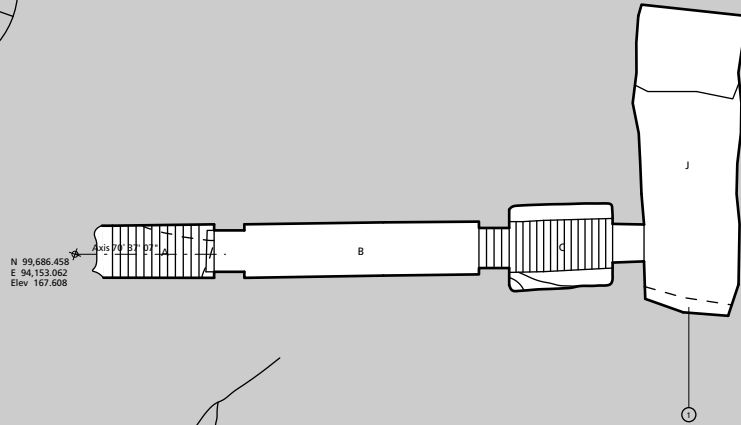
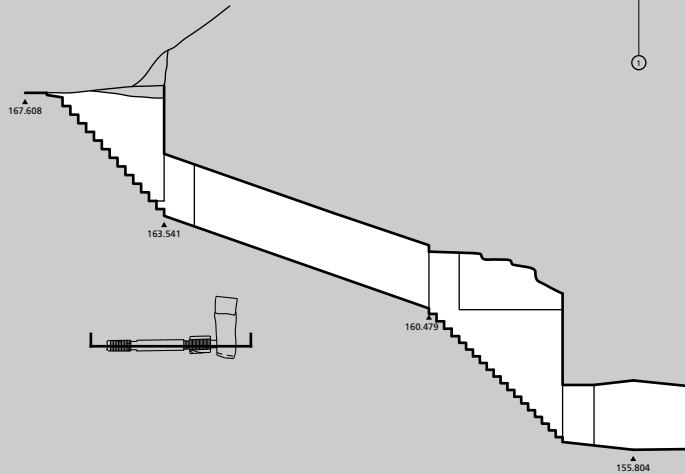
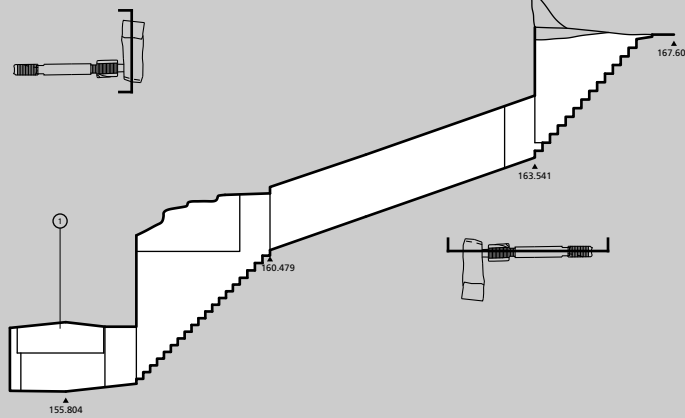
# KV 46 - Yuya Dyn. XVIII and Thuyu

NOTES	
1	Unfinished cutting of ceiling.
