Valley of the Kings & West Valley  
Plan 1:1,500 Contour Interval 10m

Sheet 1/72 - KV & WV (1/1)

Theban Mapping Project  
**KV 1 - Ramesses VII Dyn. XX**  
 Plan, sections 1:125, Axonometric  
 Sheet 7/72 - KV 1 (1/1)

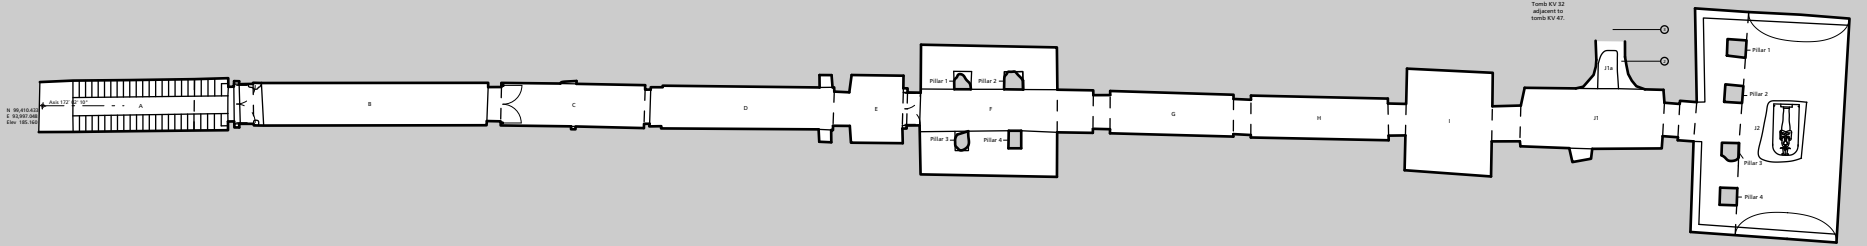
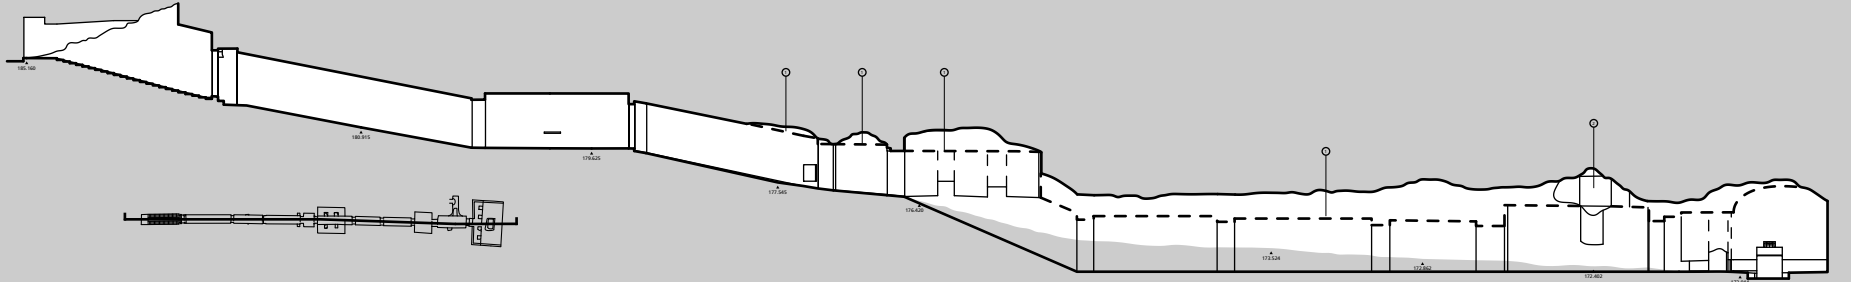
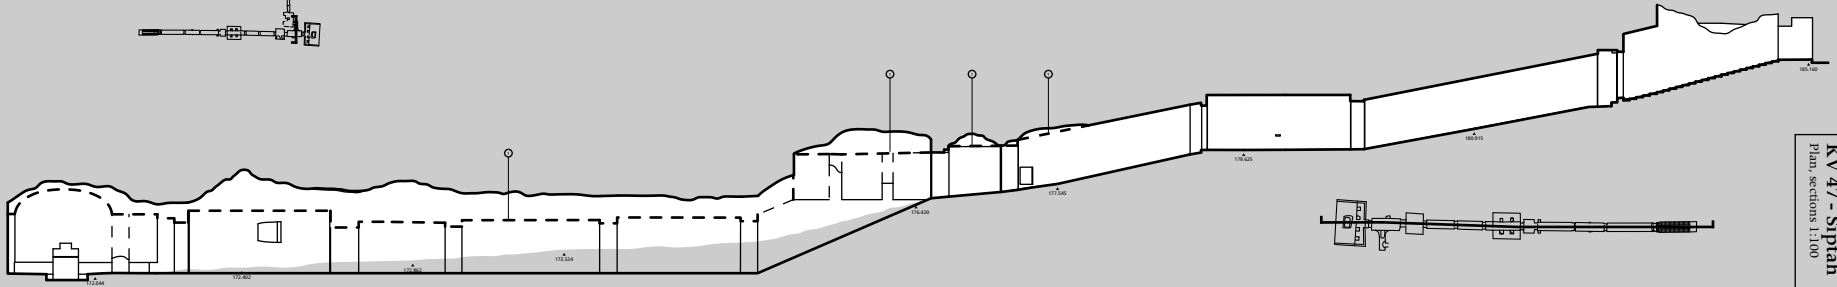
British  
 Museum  
 Egypt  
 KV 47 - Siptah  
 Dyn. XIX  
 Sheet 61/72 - KV 47 (1/2)  
 Plan, sections 1:100

NOTES	
1	Trace of original ceiling, ceiling collapsed above.
2	Assumed ceiling for measured burial chamber.
3	Reconstruction, see KV 25.

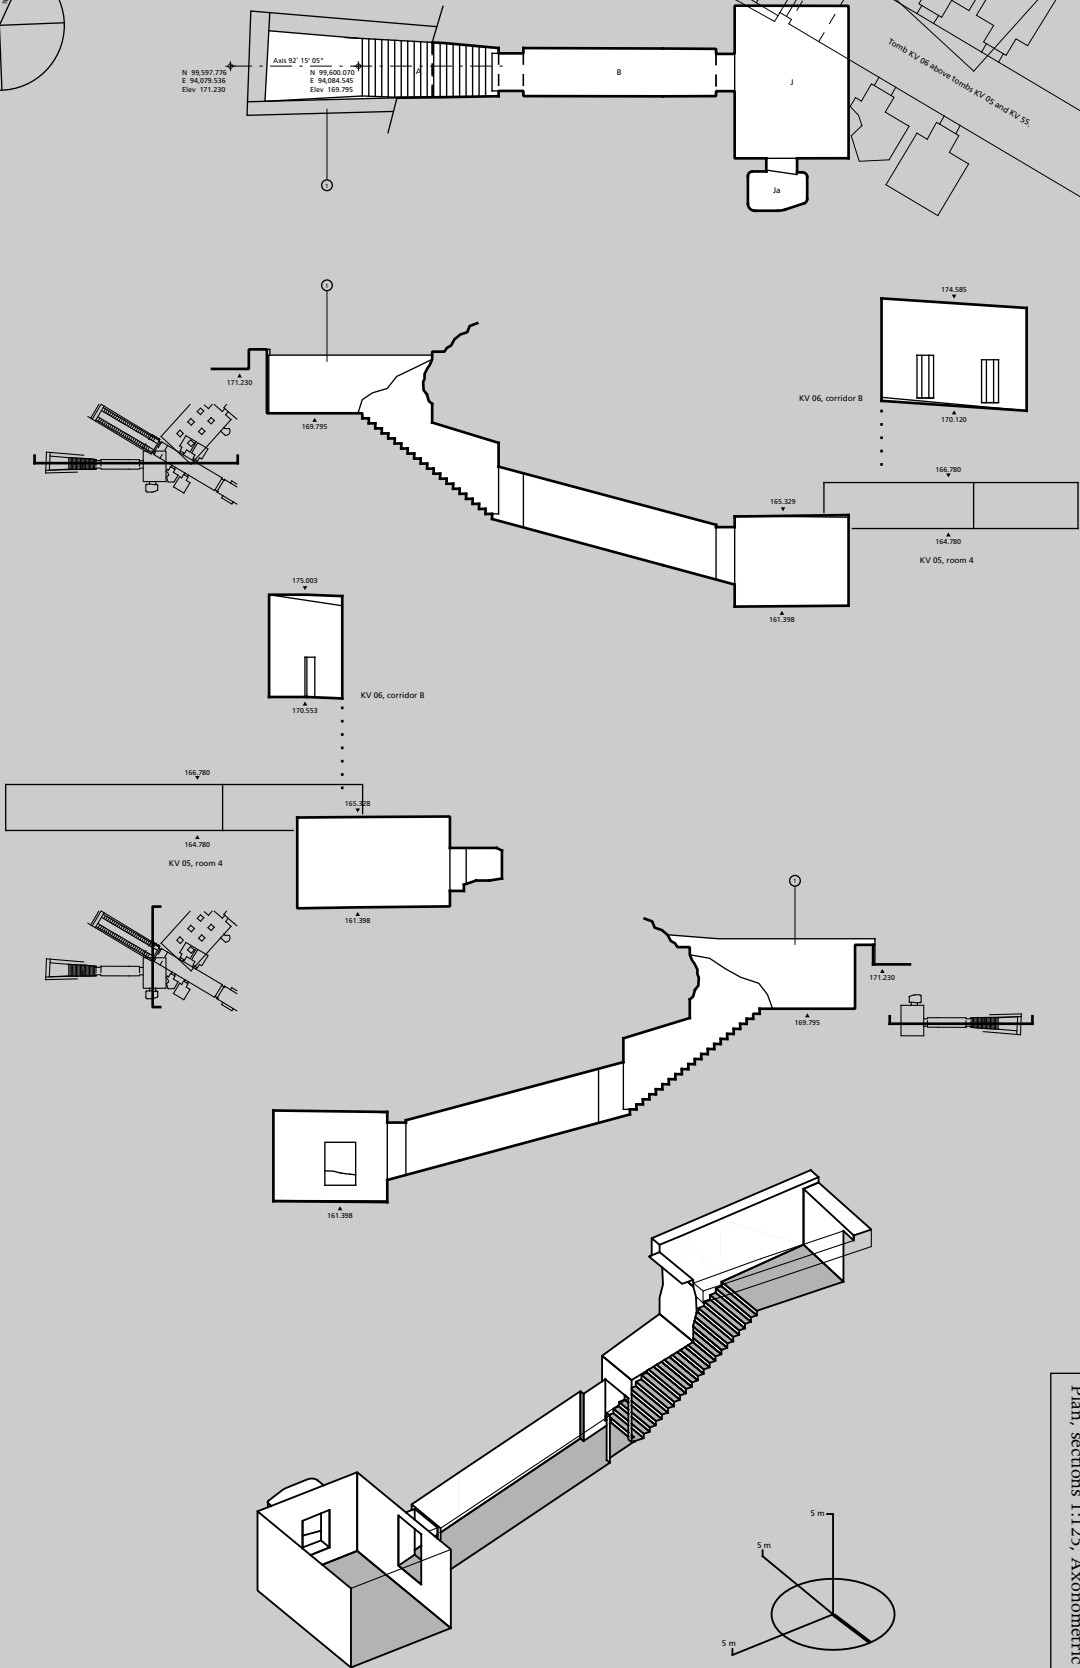
**KV 55 -**  
**Amarra Cache**  
 Plan, sections 1:125, Axonometric  
**Dyn. XVIII**  
 Sheet 65/72 - KV 55 (1/1)

NOTES	
1.	Modern retaining wall.

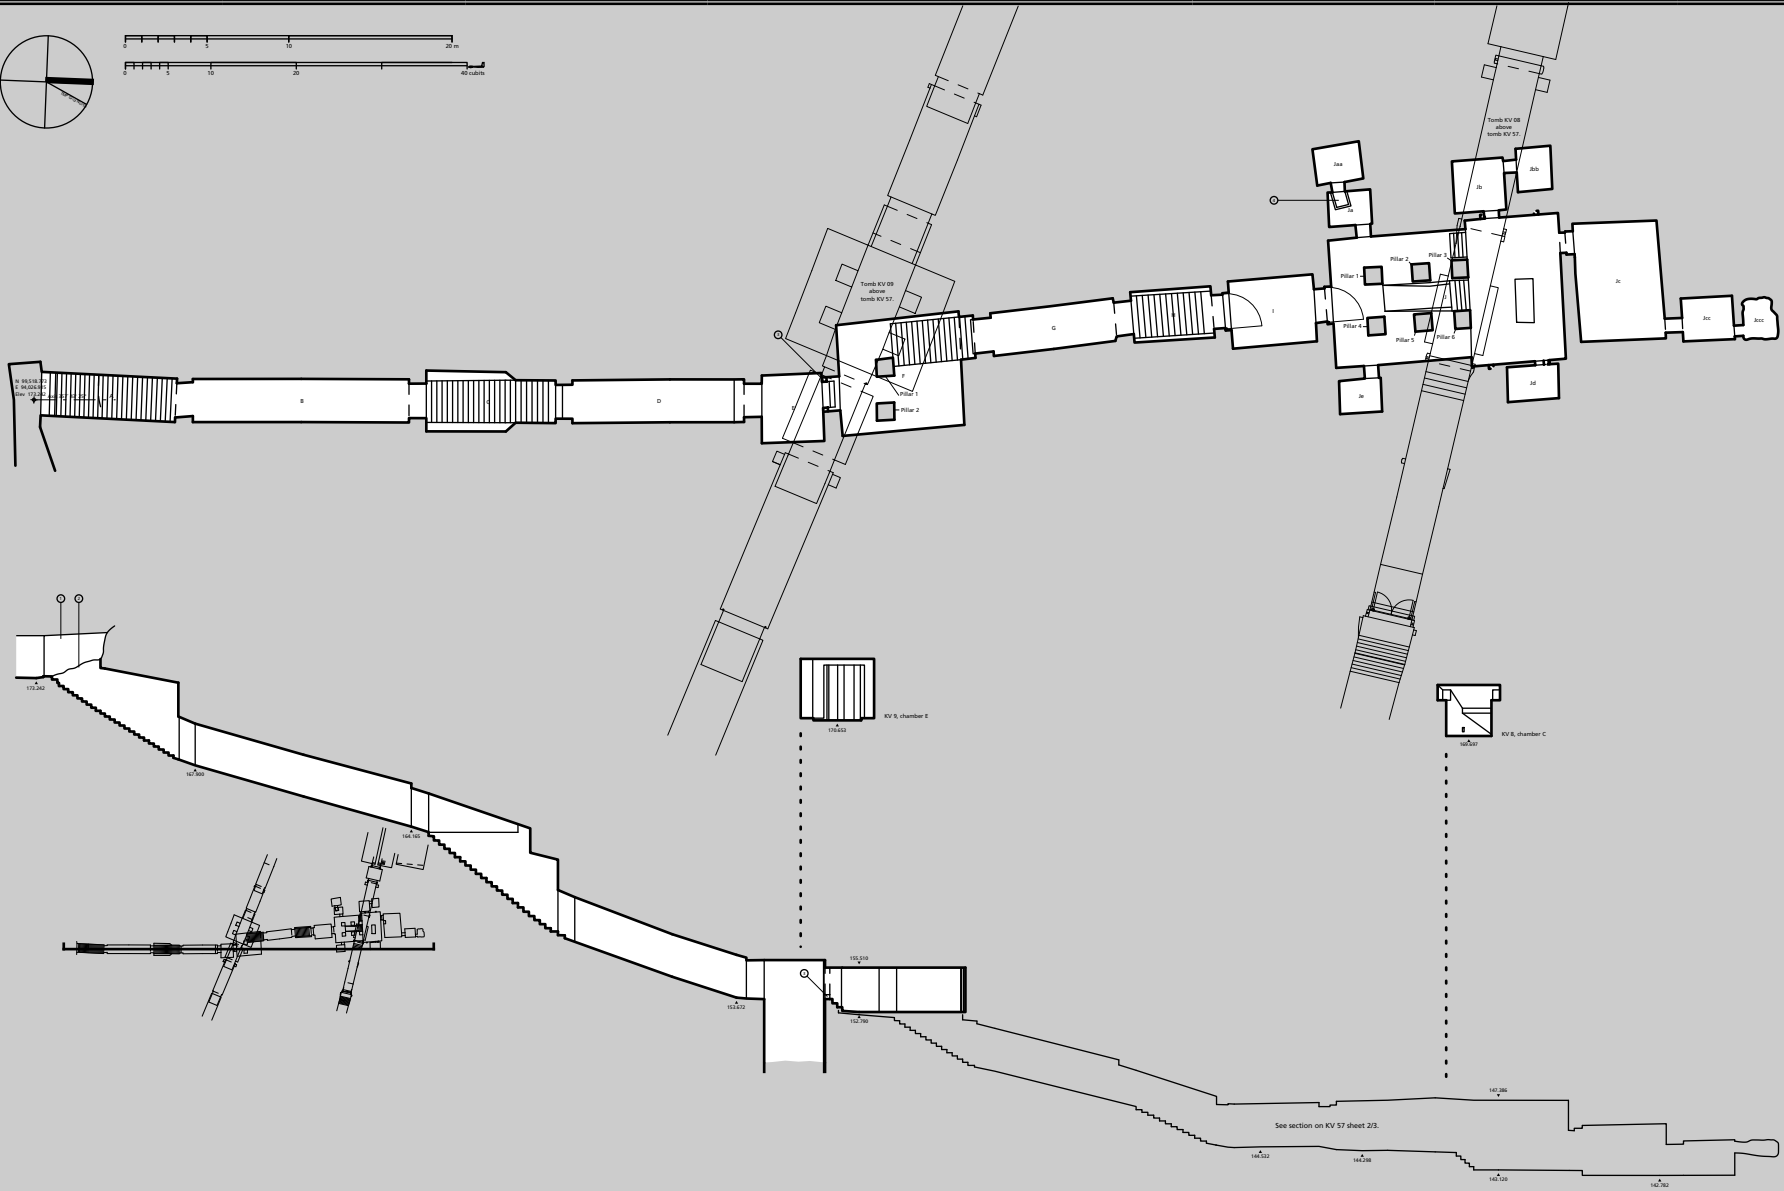
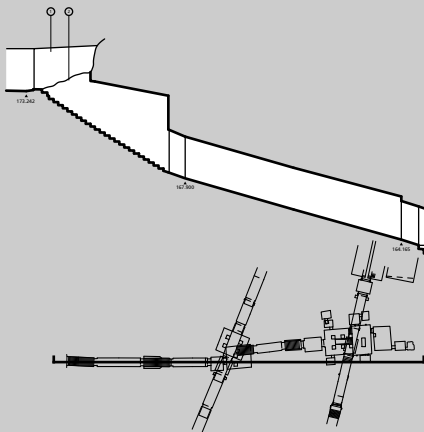
**KV 57 - Horemheb Dyn. XVIII**  
Sections 1:125

NOTES	
1	Modern retaining wall.
2	Original hillside.
3	Traces of ancient blocking flank into modern steps.
4	Small openings in wall with recessed top for holdfast cover slabs.

See section on KV 57 sheet 2/3.

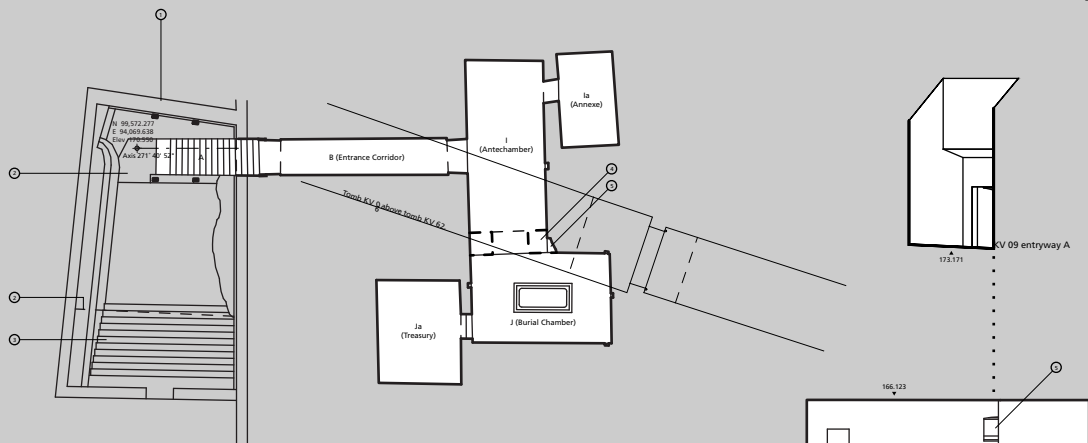
**KV 62 -**  
**Tutankhamen**  
 Plan, sections 1:125, Axonometric  
**Dyn. XVIII**  
 Sheet 71/72 - KV 62 (1/1)

NOTES	
1.	Modern retaining wall.
2.	Modern shelter over entrance supported by retaining walls and four wooden columns.
3.	Modern steps leading to the shelter and tomb entrance.
4.	Middle wall between chamber I and burial chamber J with blocked door. All removed by Carter.
5.	Unfinished gate cutting, abandoned when the burial chamber was cut into north end of the chamber I.
